MORRO BAY WATERSHED STEELHEAD RESTORATION PLANNING PROJECT

STREAM INVENTORY REPORT

DAIRY CREEK, 2001

Prepared to:
Coastal San Luis Resource Conservation District

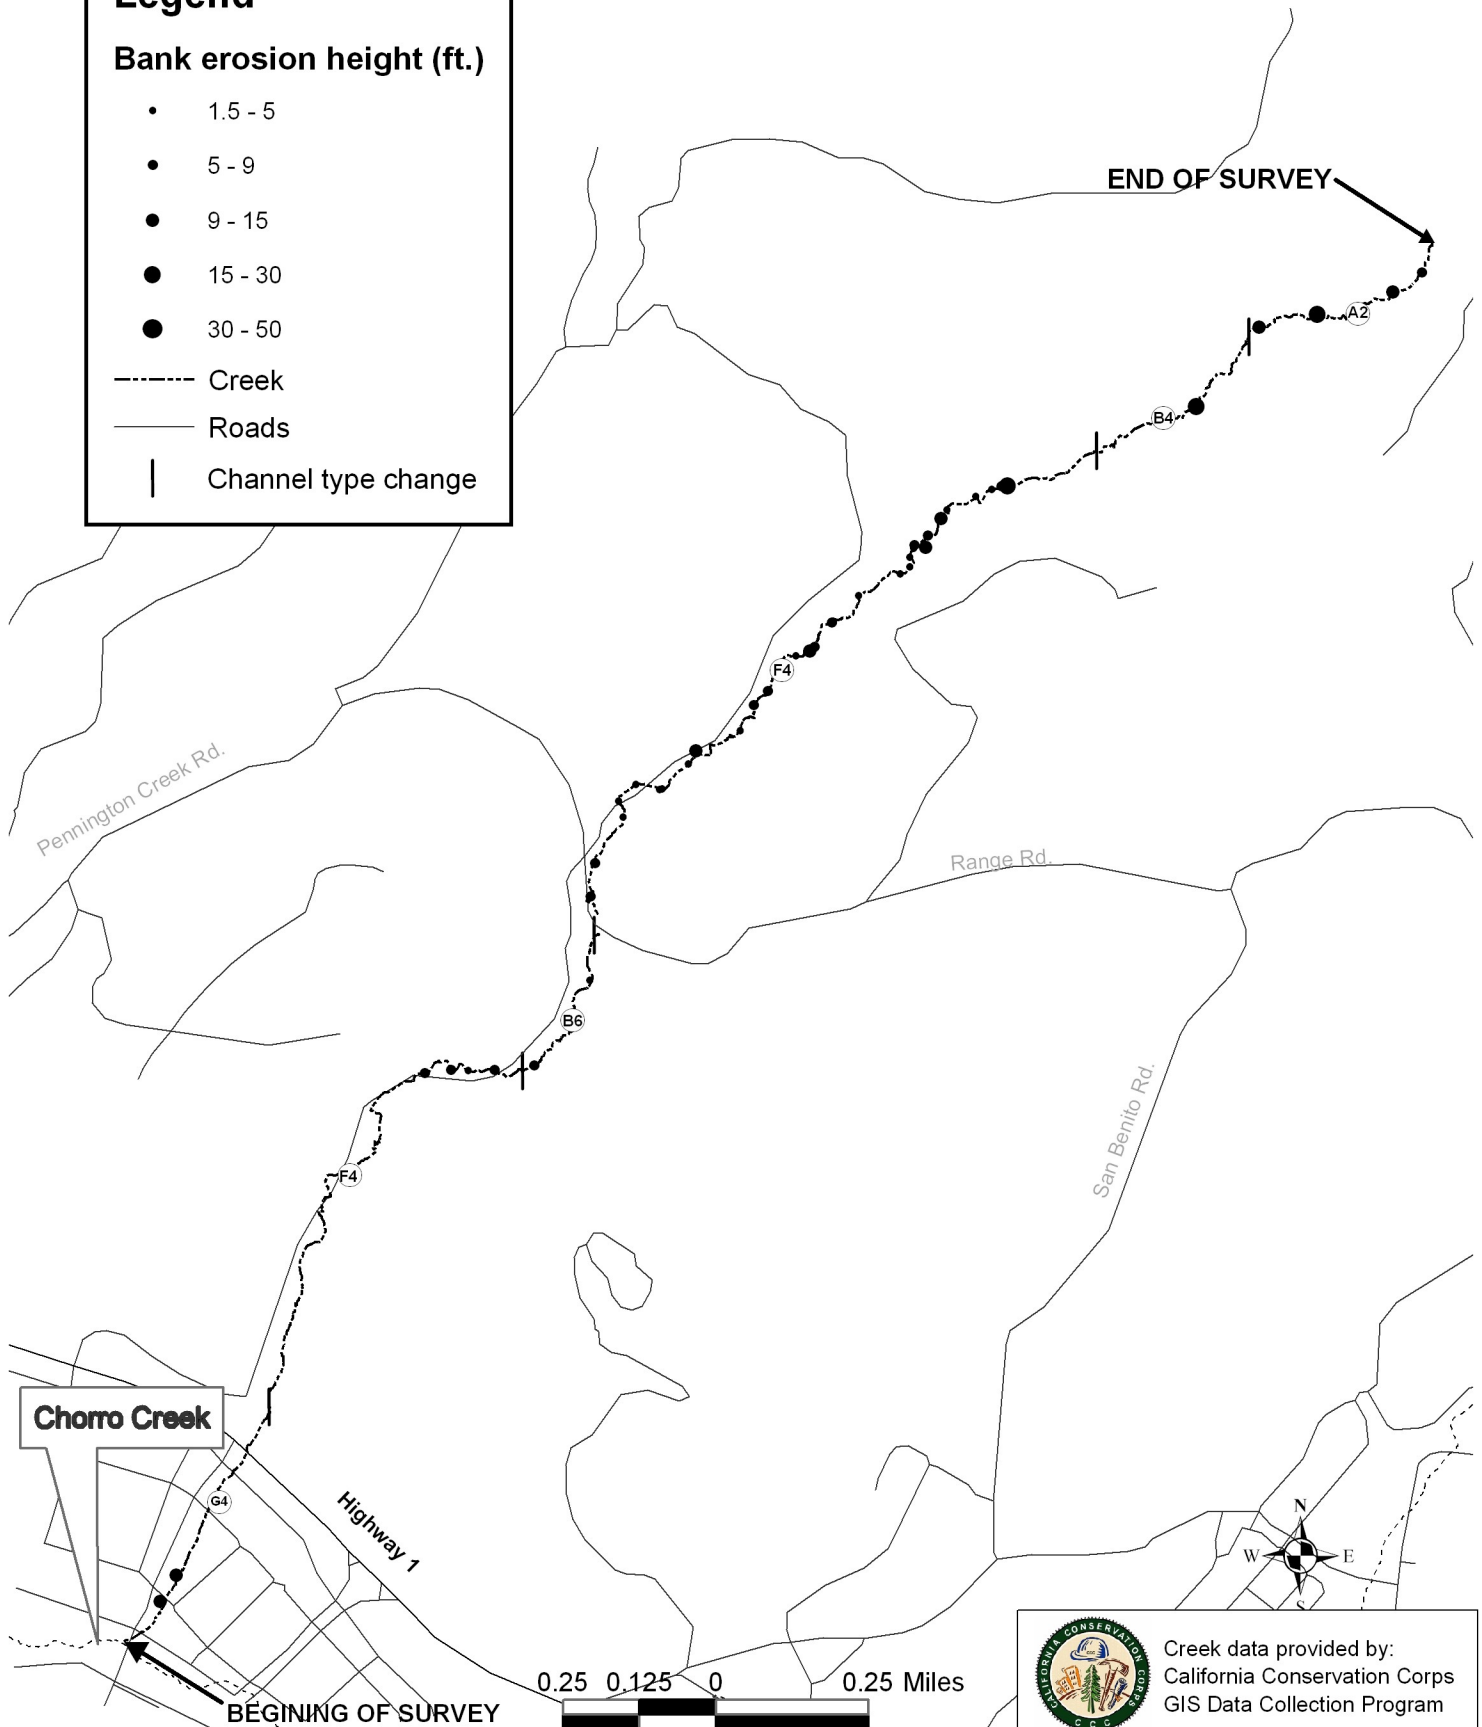
Channel Types & Stream Bank Erosion Sites

For the stream length surveyed, the mean percent right bank vegetated was 39%. The mean percent left bank vegetated was 40%. The dominant elements composing the structure of the stream banks consisted of 9% bedrock, 10% boulder, 8% cobble/gravel, and 73% sand/silt/clay (Graph 10). Deciduous trees were the dominant vegetation type observed in 46% of the units surveyed. Additionally, 21% of the units surveyed had grass as the dominant vegetation type, and 21% had coniferous trees as the dominant vegetation, including down trees, logs, and root wads (Graph 11). Areas of eroded banks along Dairy Creek are shown on Map 1.

- 4) Inventory and map sources of stream bank erosion and prioritize them according to present and potential sediment yield. Identified sites should then be treated to reduce the amount of fine sediments entering the stream.

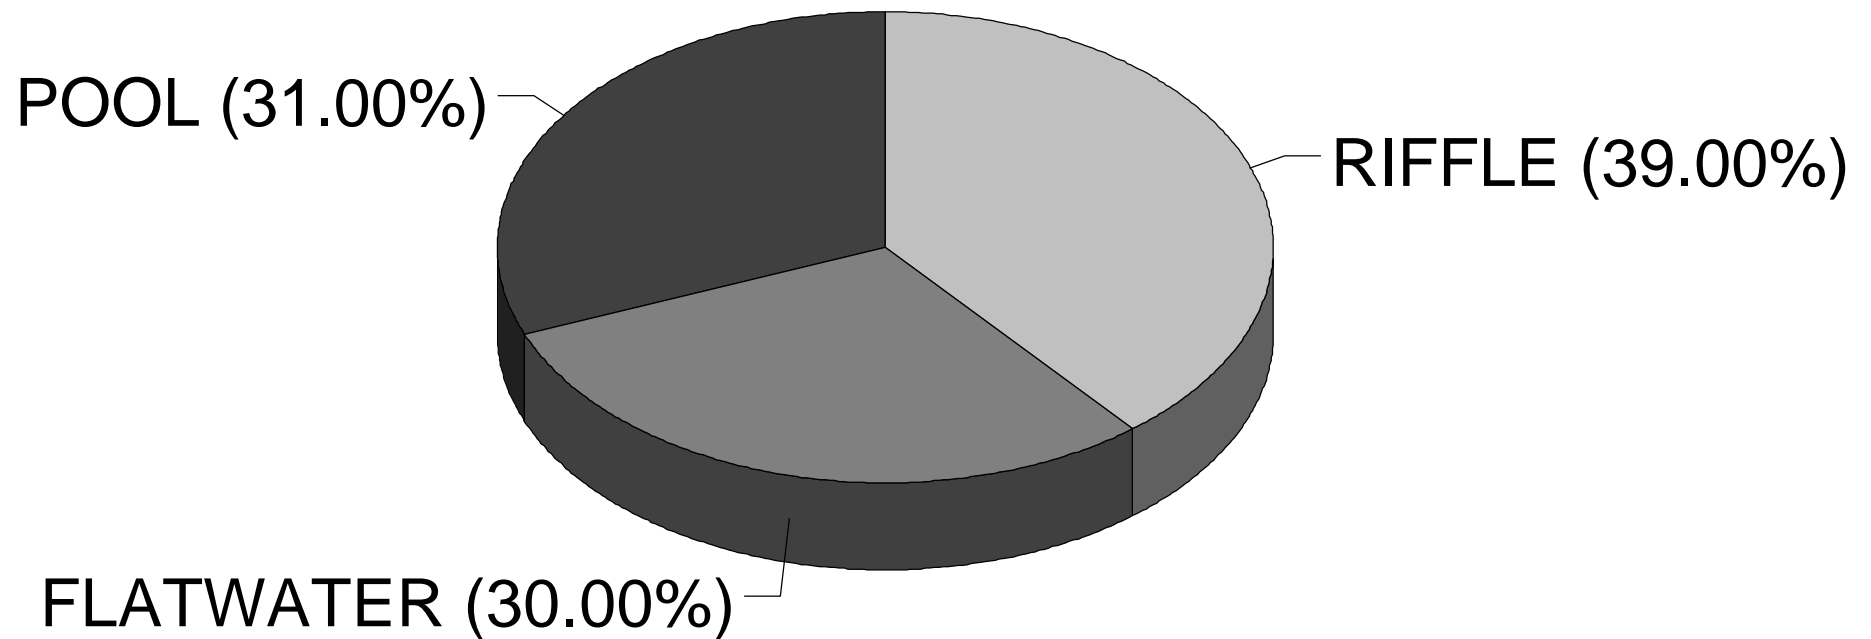
GRAPH 1

Table 1 summarizes the Level II riffle, flatwater, and pool habitat types. Based on frequency of **occurrence** there were 39% riffle units, 30% flatwater units, and 31% pool units (Graph 1). Based on total **length** of Level II habitat types there were 40% riffles, 36% flatwaters, and 22% pools (Graph 2).

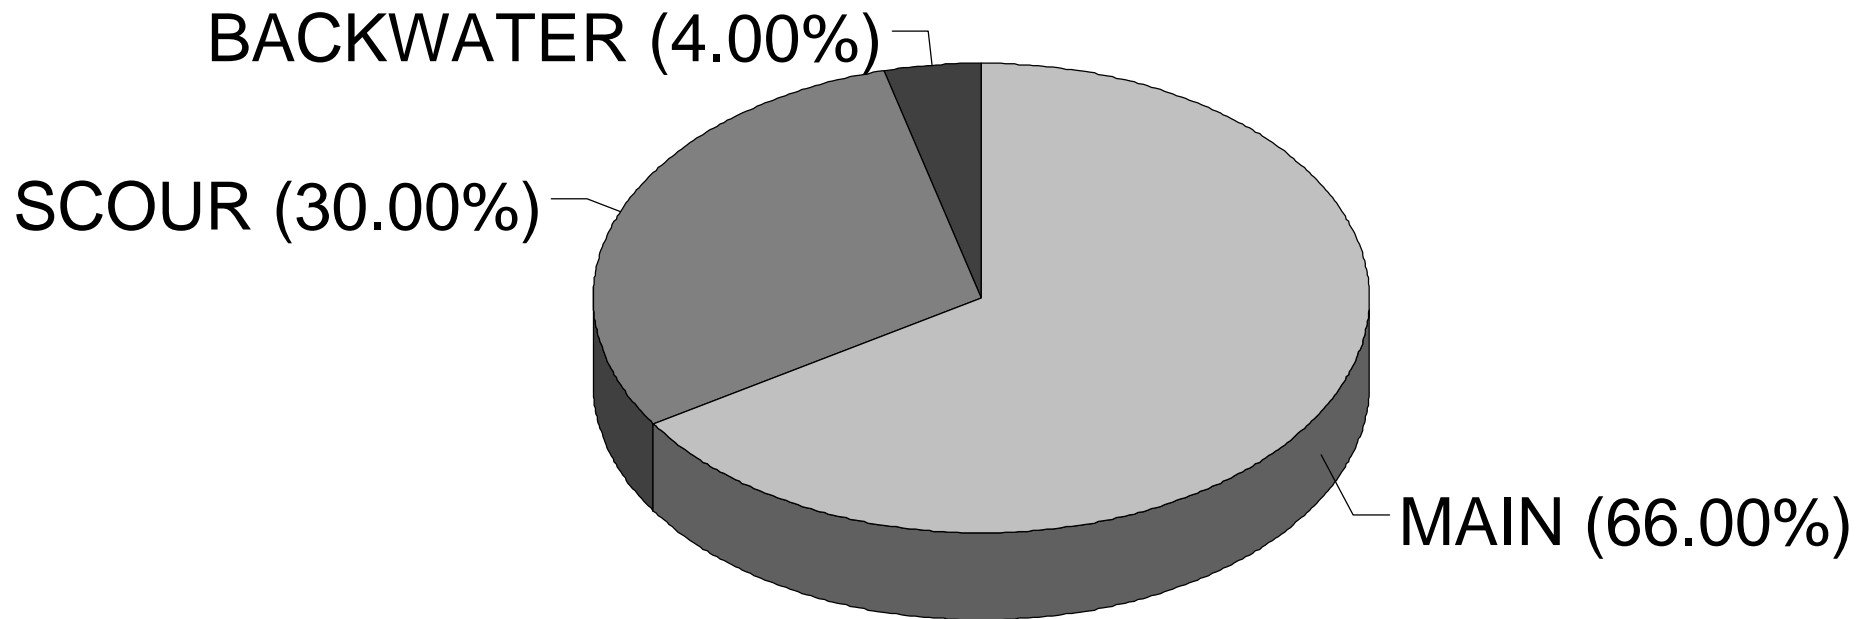
GRAPH 4

A total of 186 pools were identified (Table 3). Main-channel pools were most frequently encountered, at 66%, and comprised 69% of the total length of all pools (Graph 4, Table 3).

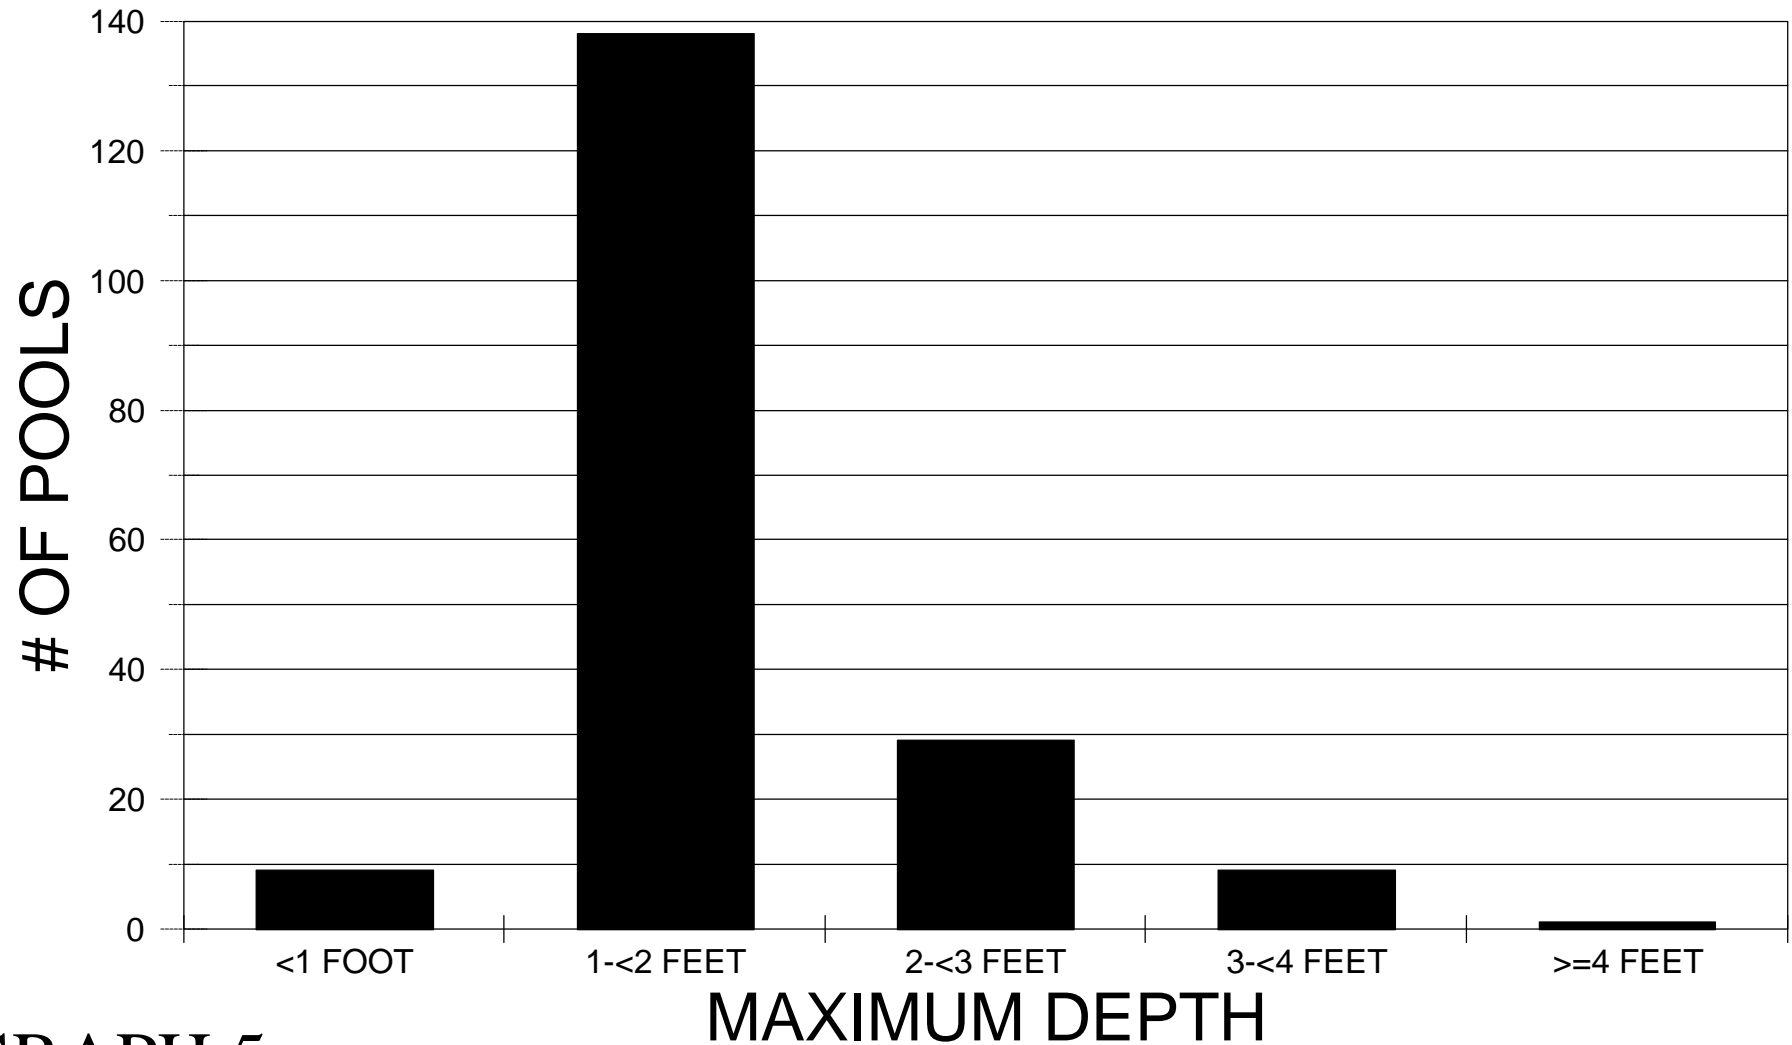
GRAPH 5

Table 4 is a summary of maximum pool depths by pool habitat types. Pool quality for salmonids increases with depth. Thirty-nine of the 186 pools (21%) had a depth of two feet or greater (Graph 5, calculated from Table 4).

- 3) Where feasible, design and engineer pool enhancement structures to increase the number of pools. This must be done where the banks are stable or in conjunction with stream bank armor to prevent erosion.

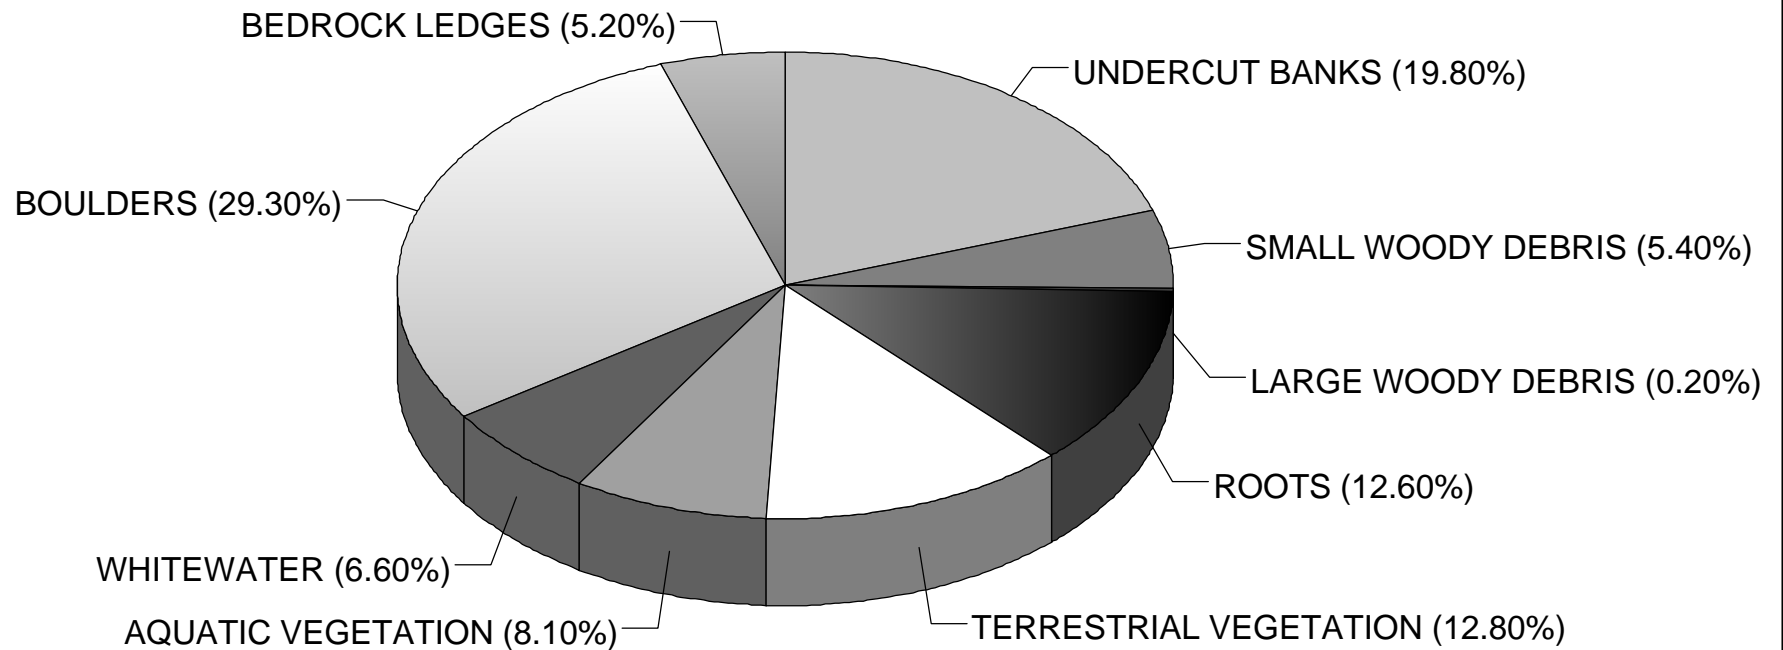
GRAPH 7

Table 5 summarizes mean percent cover by habitat type. Boulders are the dominant cover type in Dairy Creek. Undercut bank is the next common cover type. Graph 7 describes the pool cover in Dairy Creek.

- 1) Dairy Creek should be managed as an anadromous, natural production stream.
- 2) Increase woody cover in the pools and flatwater habitat units. Most of the existing cover is from boulders. Adding high quality complexity with woody cover is desirable.

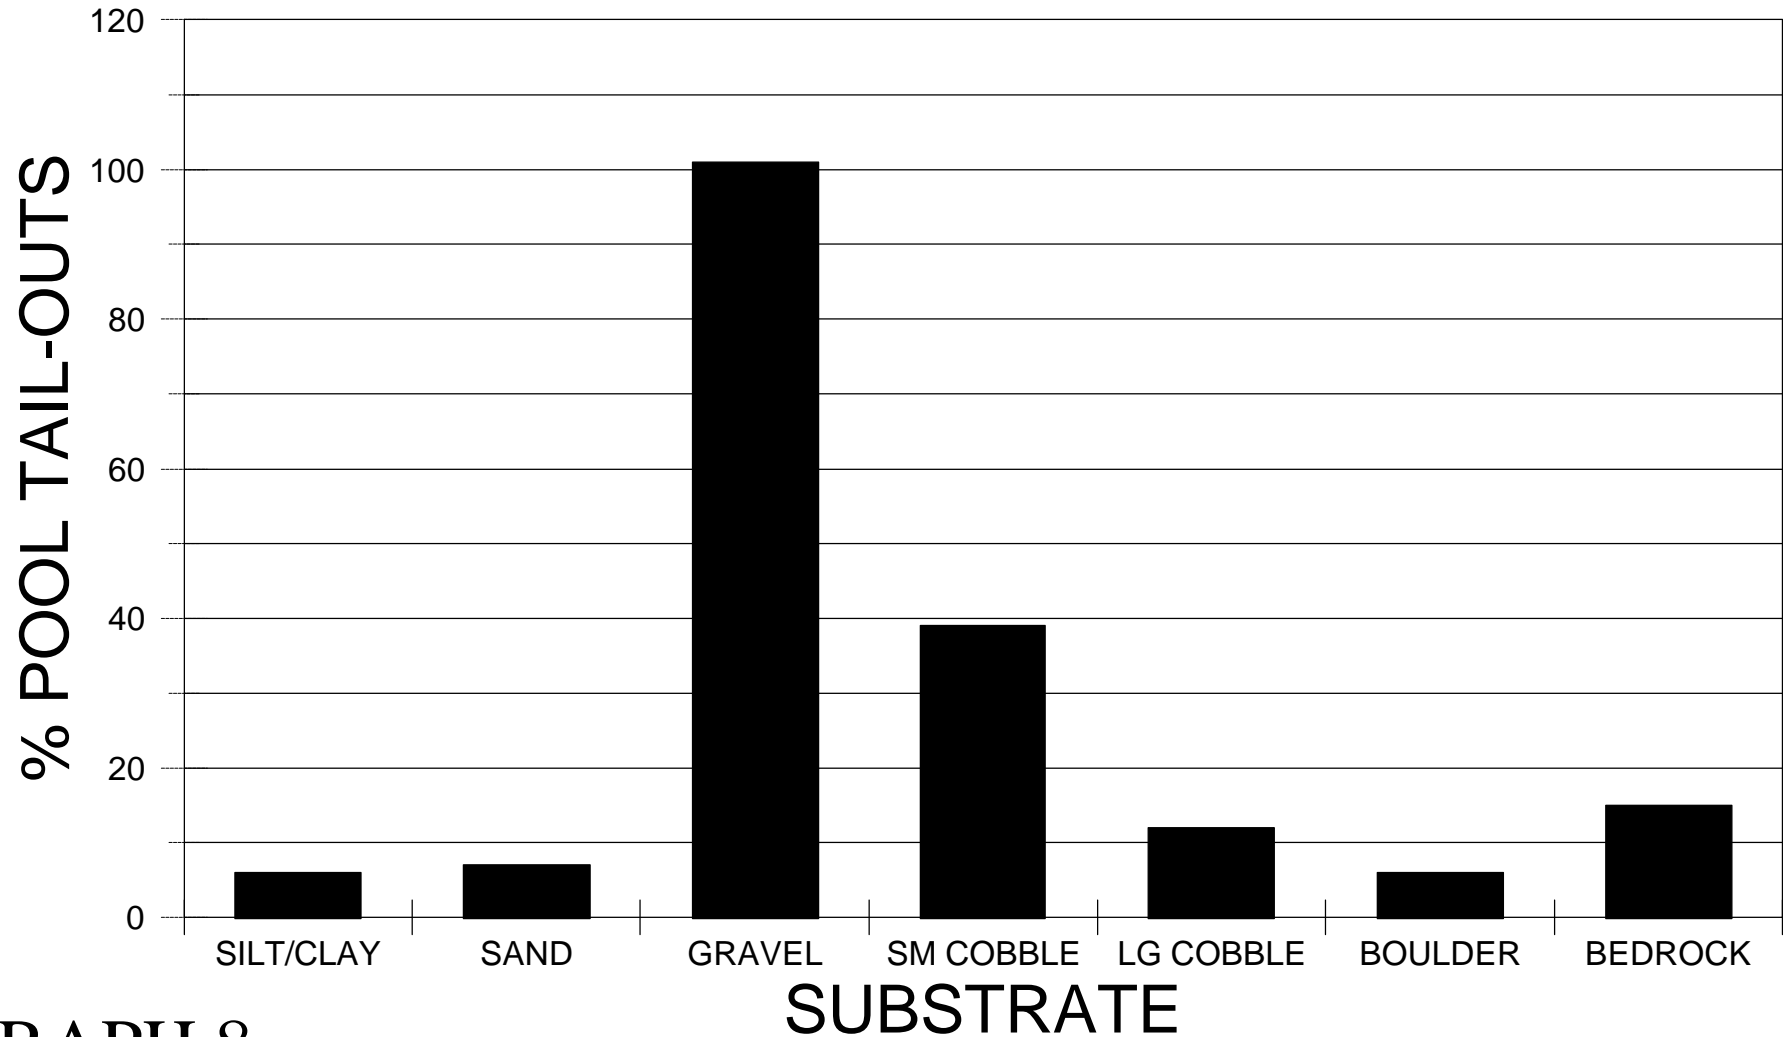
GRAPH 8

Table 6 summarizes the dominant substrate by habitat type. Gravel was the dominant substrate observed in 101 of the 186 pool tail outs measured (54%). Small cobble was the next most frequently observed dominant substrate type and occurred in 21% of the pool tail outs (Graph 8).

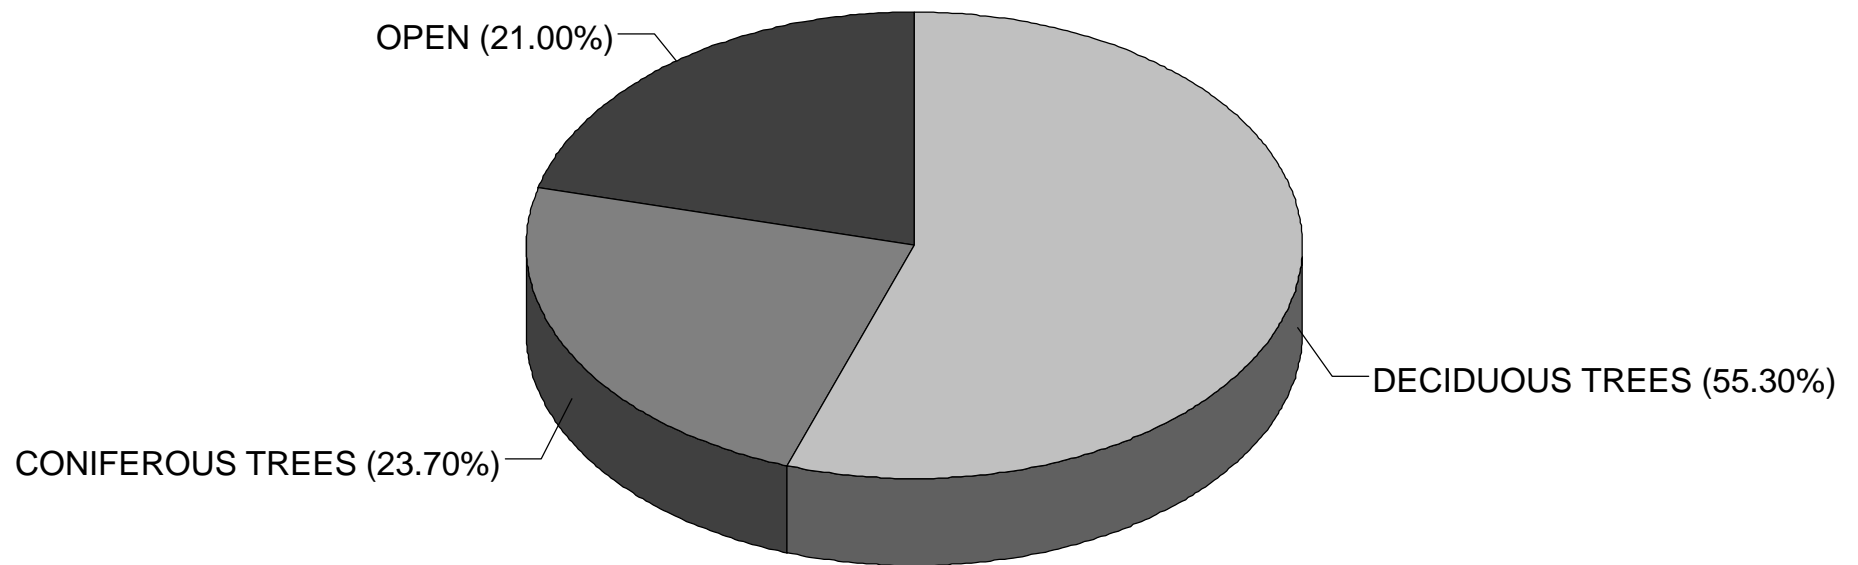
GRAPH 9

The mean percent canopy density for the stream reach surveyed was 79%. The mean percentages of deciduous and coniferous trees were 70% and 30%, respectively. Graph 9 describes the canopy in Dairy Creek.

The mean percent canopy density for the stream was 79%. This is a relatively low percentage of canopy. In general, revegetation projects are considered when canopy density is less than 80%.

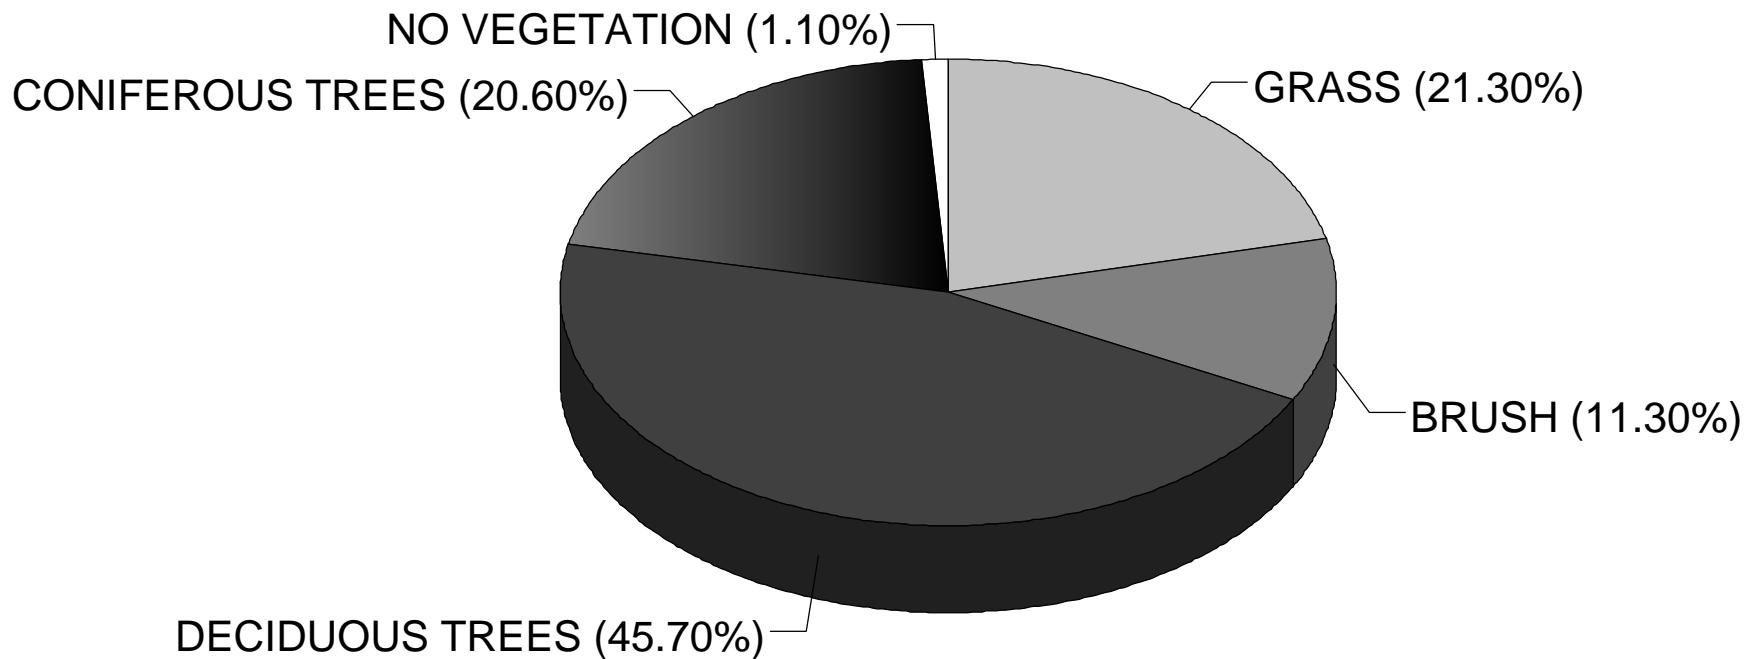
GRAPH 11

The percentage of right and left bank covered with vegetation was low at 39% and 40%, respectively. In areas of stream bank erosion or where bank vegetation is not at acceptable levels, planting endemic species of coniferous and deciduous trees, in conjunction with bank stabilization, is recommended. Eroded banks along Dairy Creek are also likely contributing sediment to spawning gravels. Map 1, which shows locations of eroded banks and their maximum height classes, can help prioritize stream bank stabilization projects in the future.
