MORRO BAY WATERSHED STEELHEAD RESTORATION PLANNING PROJECT

STREAM INVENTORY REPORT

CHORRO CREEK, 2001

Prepared to:
Coastal San Luis Resource Conservation District

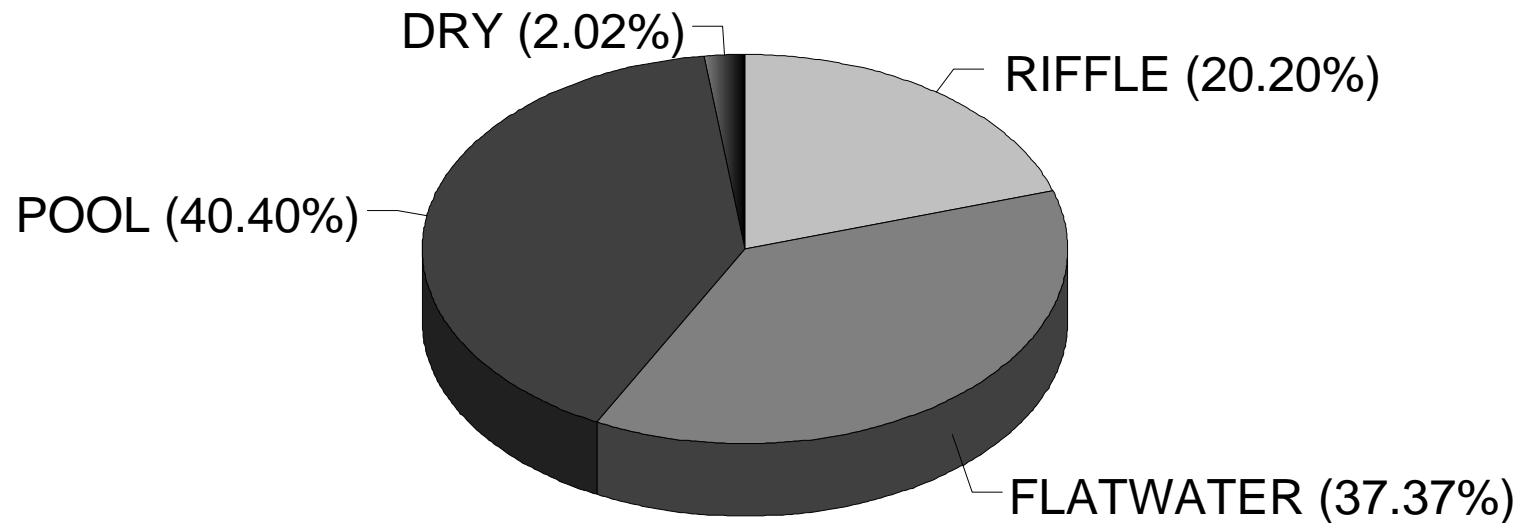
GRAPH 1

Table 1 summarizes the Level II riffle, flatwater, and pool habitat types. Based on frequency of occurrence there were 20% riffle units, 37% flatwater units, and 40% pool units (Graph 1). Based on total length of Level II habitat types there were 14% riffles, 43% flatwater units, and 33% pools (Graph 2).

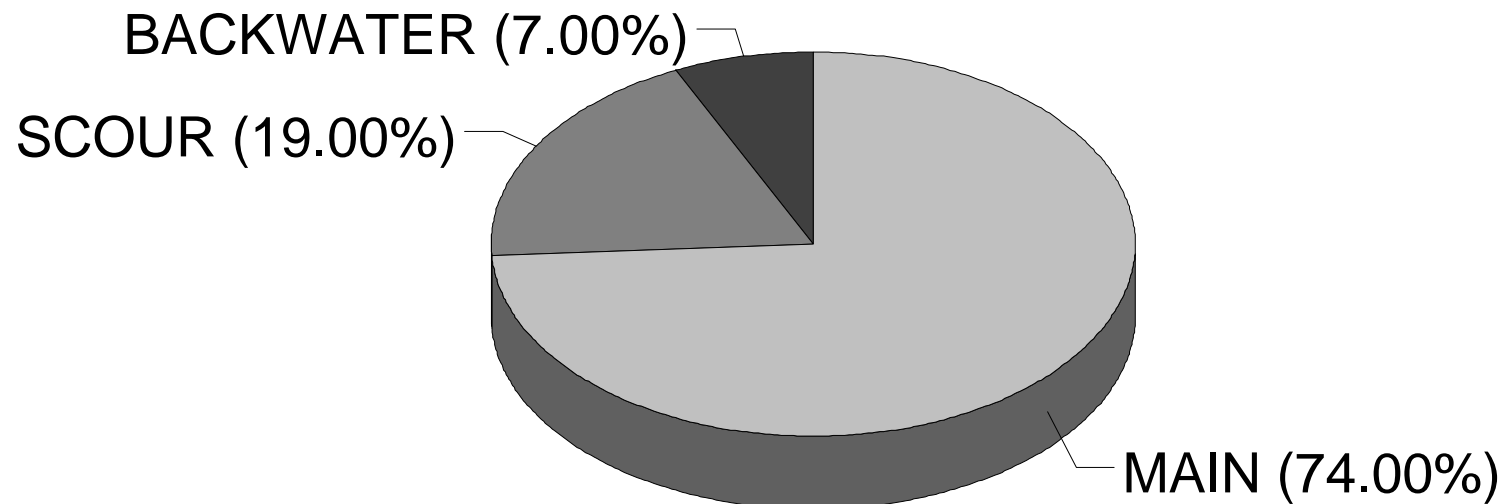
GRAPH 4

A total of 241 pools were identified (Table 3). Main-channel pools were most frequently encountered at 74% and comprised 82% of the total length of all pools (Graph 4).

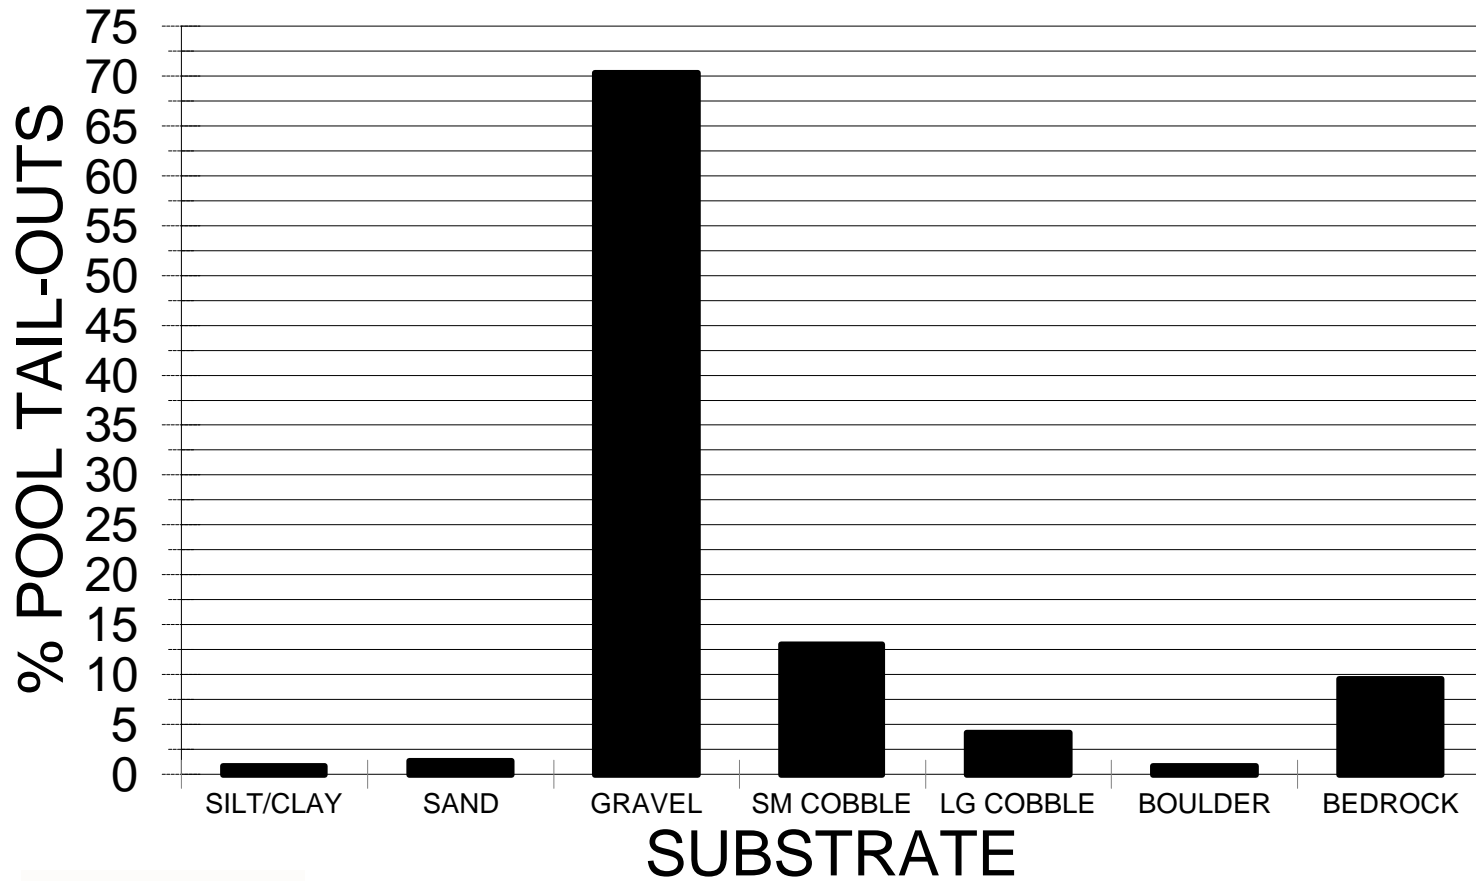
GRAPH 8

Table 6 summarizes the dominant substrate by habitat type. Graph 8 shows the dominant substrate observed in pool tail-outs. Gravel was the dominant substrate observed in 70% of the pool tail outs; small cobble was the next most frequently observed substrate type at 13%.

One hundred and ninety-nine of the 239 pool tail outs measured had gravel or small cobble as the dominant substrate. This is generally considered good for spawning salmonids.
