ARROYO GRANDE CREEK

40th ANNIVERSARY 1958-1998

Arroyo Grande Creek PL 566 Project 1952-1961

Official NRCS (SCS) Report 1999 AG Creek O&M Inspection (opposite page 13)

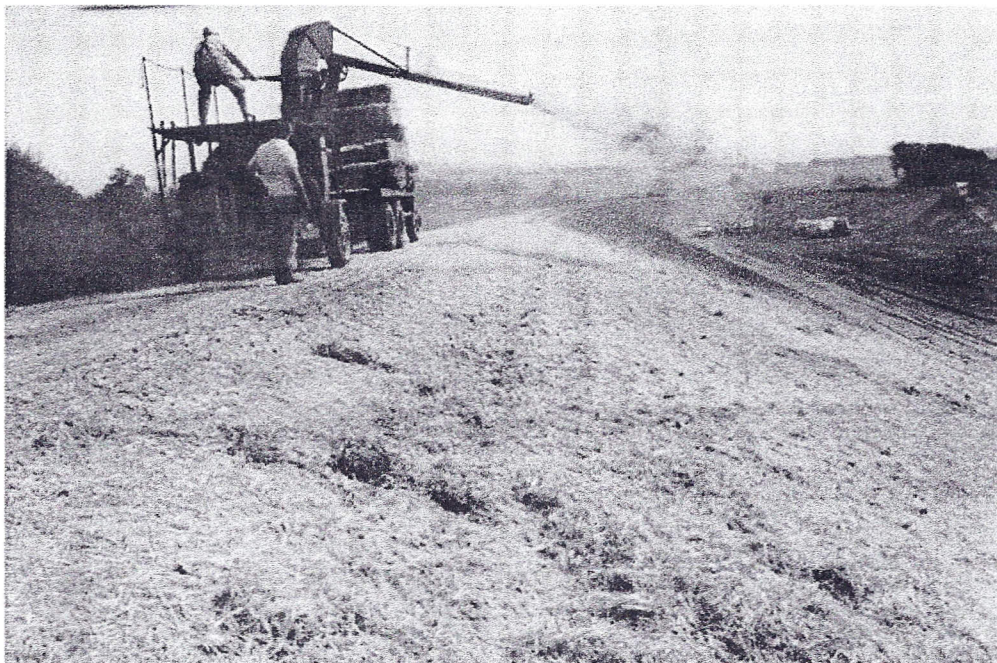
AG SCD PL 566 -Straw blowing machine placing straw on side slopes of dikes. Project Contract # SLO-FC-1 11/7/57

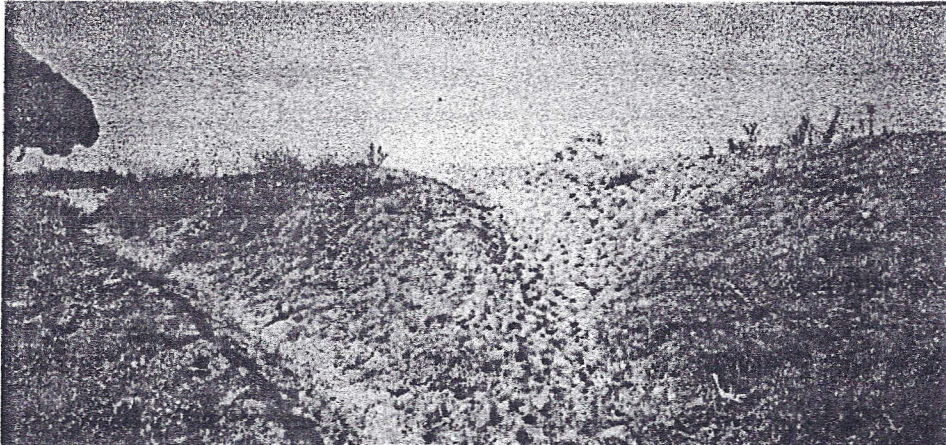
The Levees are used as riding trails and the picture documents the damage. Oct. 1999

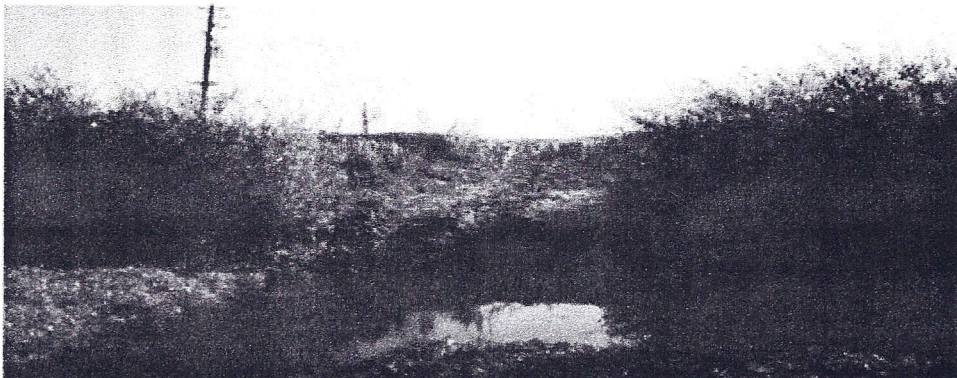
September 23, 1999 Official NRCS Report states, "No work was completed within the last year to address any of the sedimentation or structural concerns also identified in the 1997 O&M inspection letter." (Left of page 13)

1. Construct low flow ditch on one side of channel.
2. Use earthmoving equipment on other side of channel to restore channel to original design.
3. Move low flow ditch to other side of the channel.
4. Use earthmoving equipment to restore channel.
5. Remove low flow ditch.
6. Plan for mitigation of temporal displacement of wetlands by creating wetland on a 1:1 basis on land adjacent to the channel. Hold the funds for this work in abeyance for one to two years. During this time, seek matching funding for a project above and beyond this mitigation. If matching funds are not found implement planned mitigation.
