Summary of 319h Projects and Practices Implemented through Grant No. 06-128-553-0 "Project Clearwater"

ATTACHMENT E
[San Bernardo Creek Managed Grazing Project PC-04-10](#)

ATTACHMENT E
Grade Stabilization Turri Road Ranch House PC-05-15

[Los Osos Valley Horse Manure Composting Project PC-06-08](#)

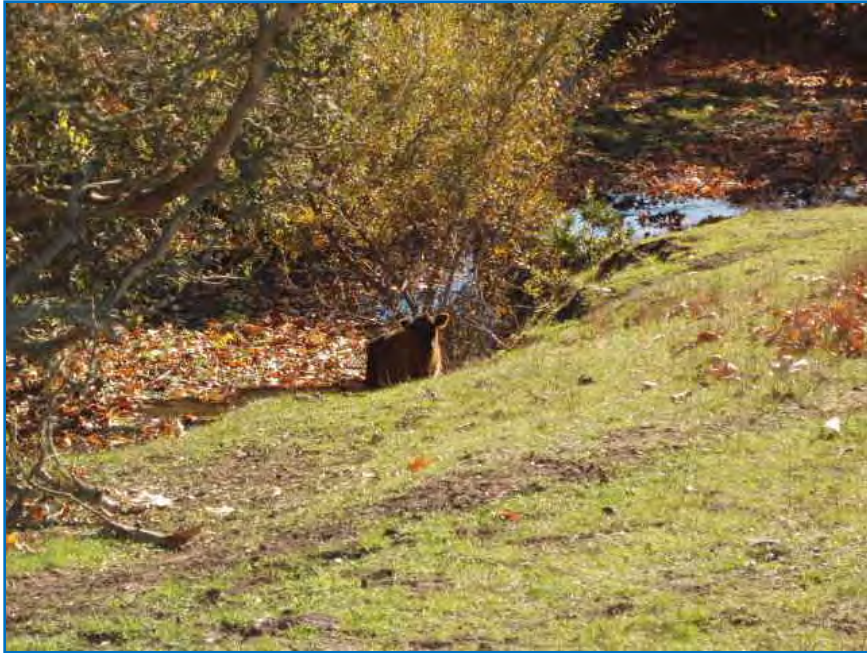
Figure 1. Cattle in creek

Resource concern: impaired water quality and riparian vegetation due to cattle in creek; water quality parameters of concern include pathogens.

Solution: Develop a Comprehensive Conservation Plan that includes riparian fencing and an off - creek watering system for cattle.

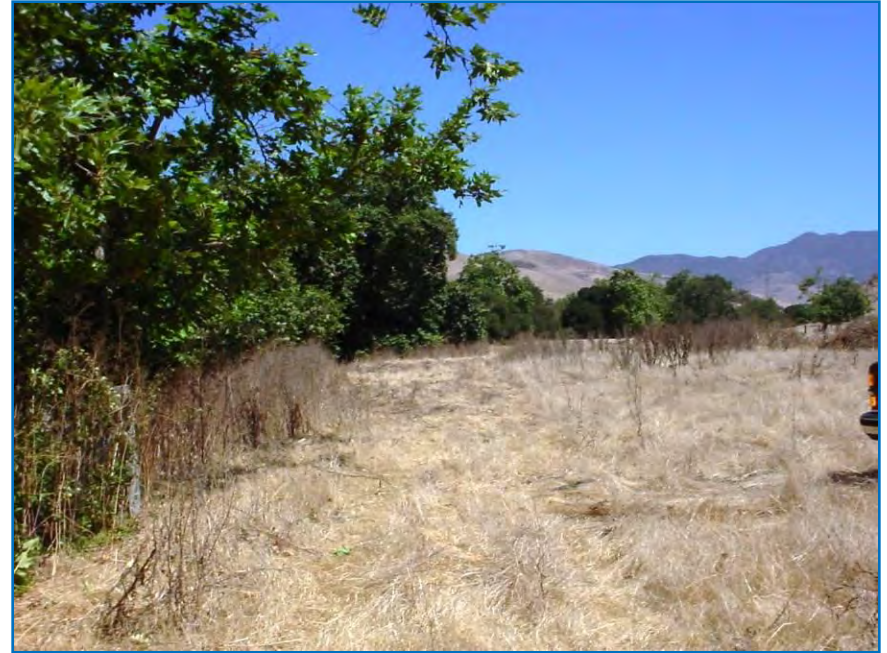
Figure 2. No fence or barrier to cattle access to creek.

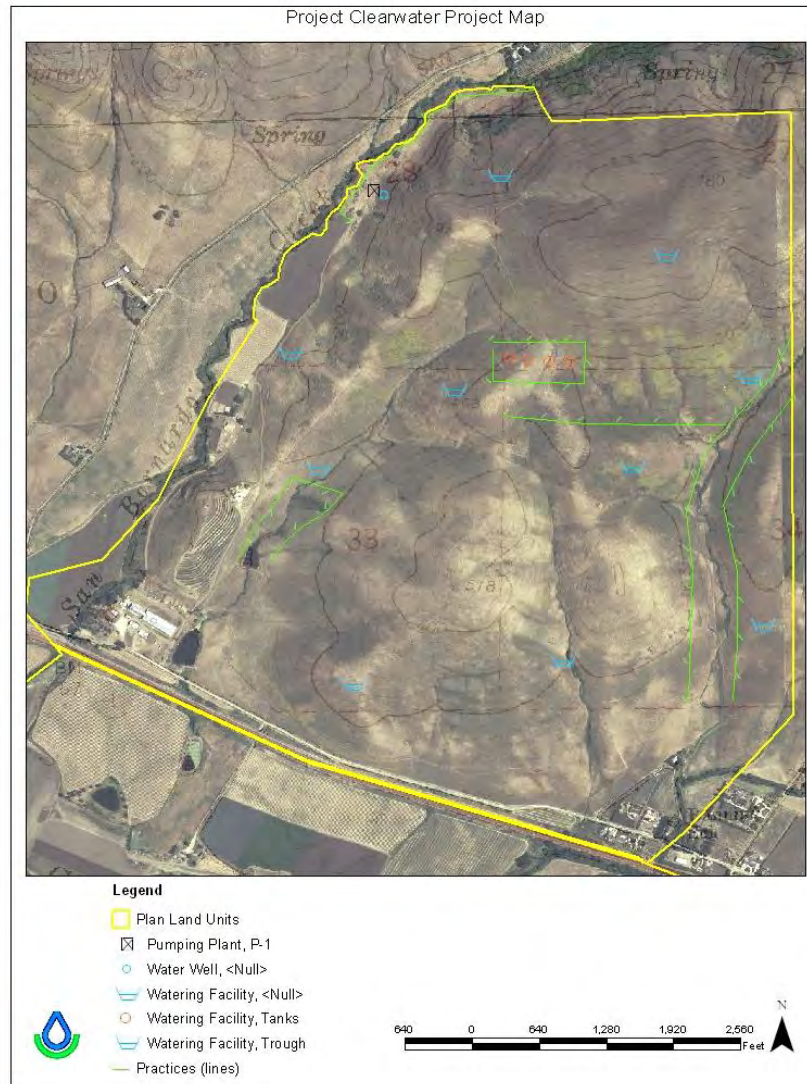
Figure 3. As-built off-creek watering system and riparian fencing plan for San Bernardo Creek Managed Grazing Project.

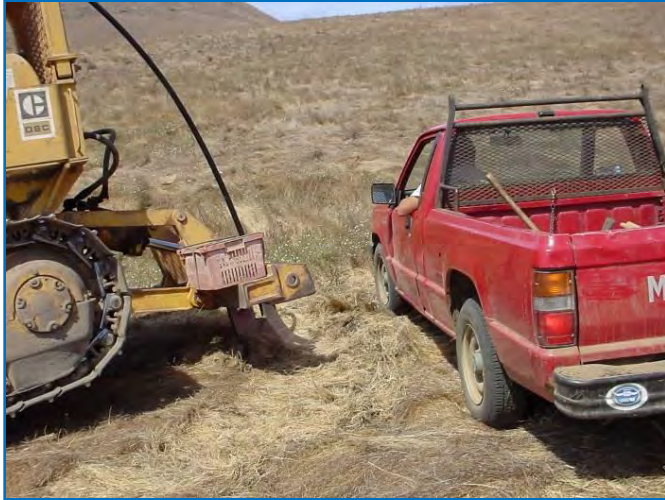
Figure 4. Rip shank and pipe feeder.

Construction: Views of caterpillar installing pipe into ground, and minimal impact after ditch is refilled by dozer following cat. Over 13,000 feet of pipeline were installed in this off-creek watering project.

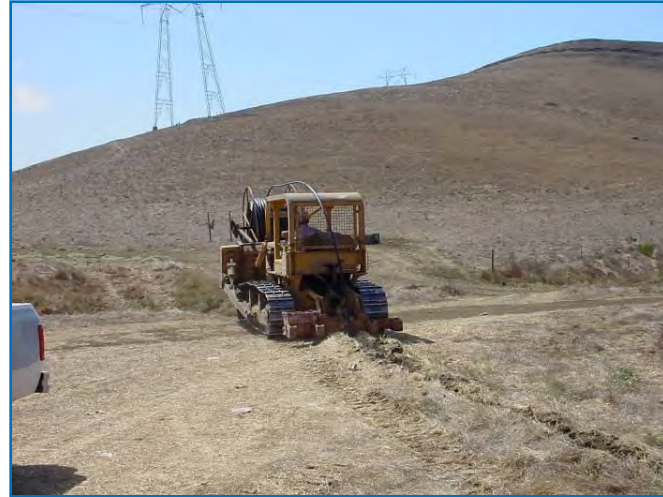
Figure 5. Close-up of cat ripping pipe into ground.

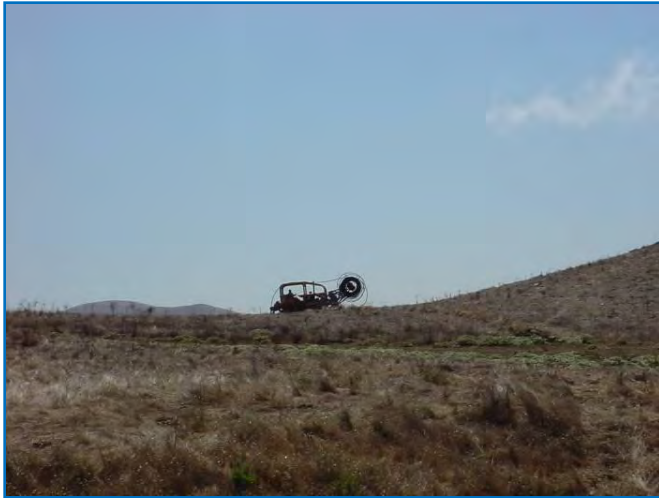
Figure 6. Distant view of cat ripping in pipe – note spool of pipe on right side of cat.

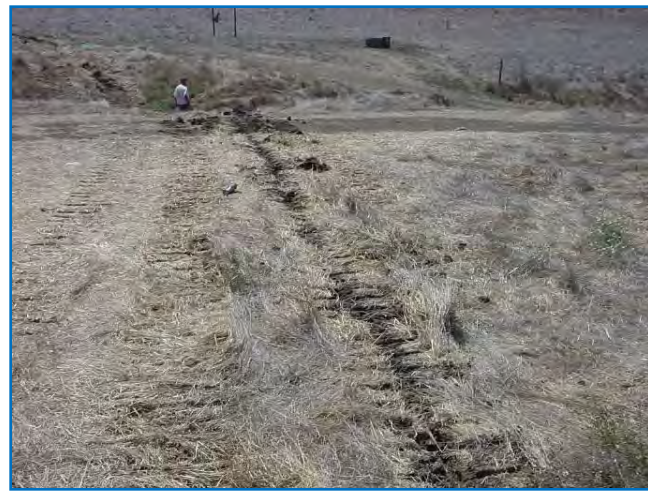
Figure 7. After pipe installation – minimal soil impact.

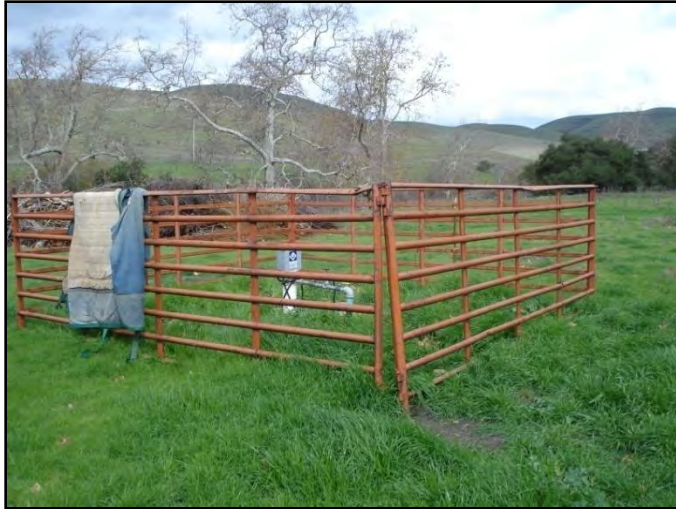
Figure 13a. Well and generator (Feb 2009).

Post-implementation photos: A site visit conducted February 6, 2009 found the riparian fencing and off-creek watering system in excellent condition.

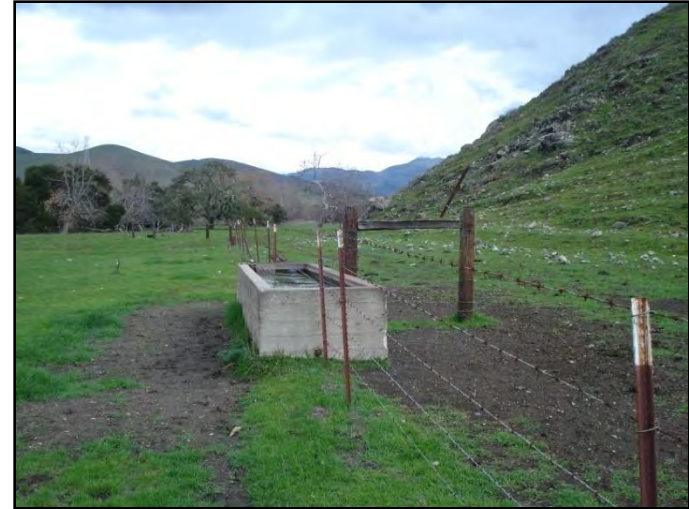
Figure 13b. Cattle watering trough.

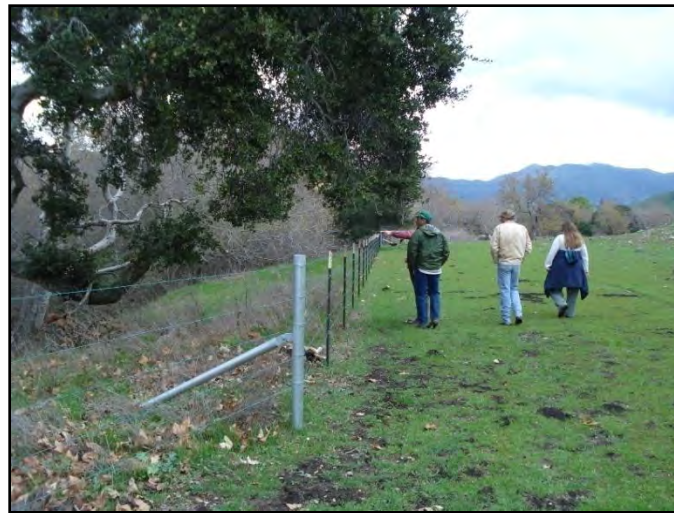
Figure 13c. Riparian fencing protecting San Bernardo Creek (Feb. 2009)

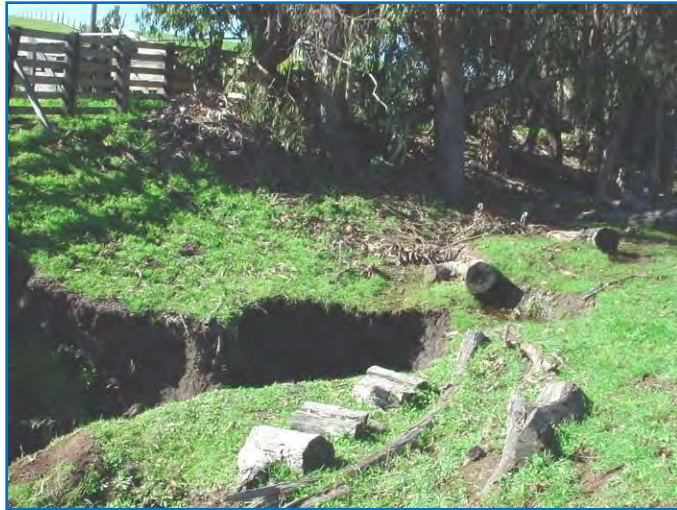
Figure 14. View of headcut, looking from left bank to right bank.

Resource concern: The head cut and a sloughing bank contribute to sediment loading into Warden Creek.

Solution: Install drop structure to eliminate head cut; backfill around drop structure; fill in head cut to support sloughing bank.

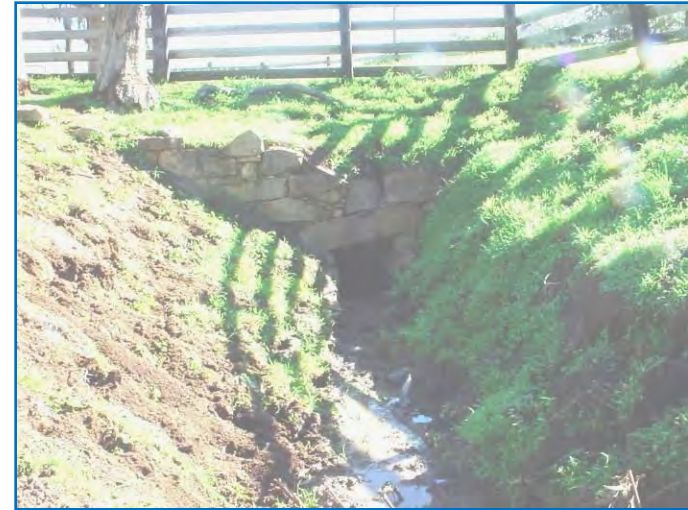
Figure 15. Looking downstream at entrance of existing rock culvert.

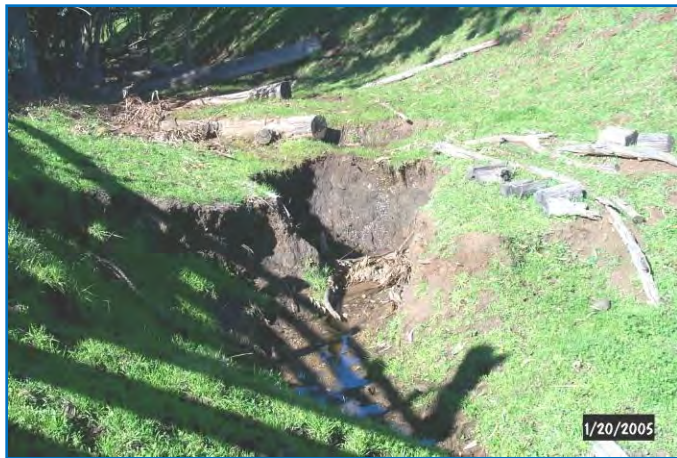
Figure 16. Another view of headcut.

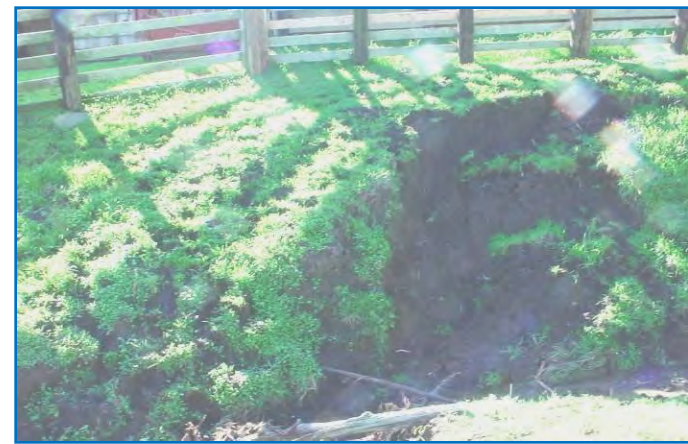
Figure 17. Sloughing bank.

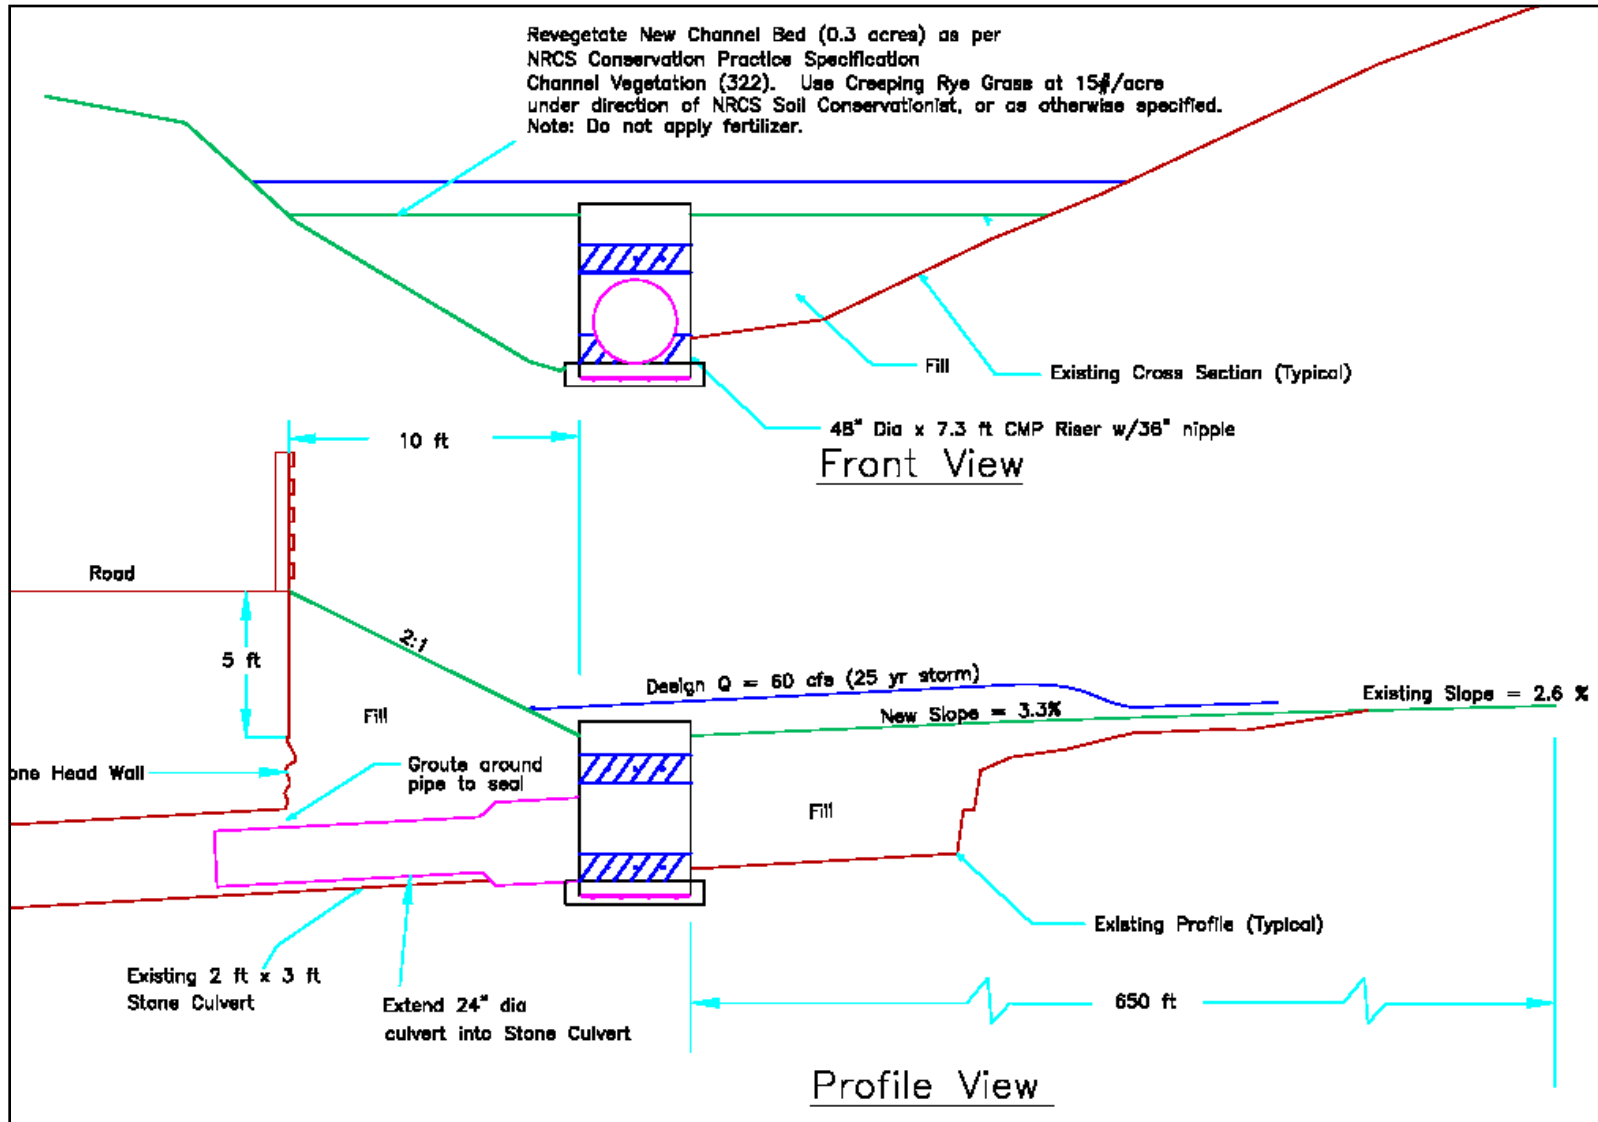
Figure 18. Diagram of drop structure and treatment of headcut.

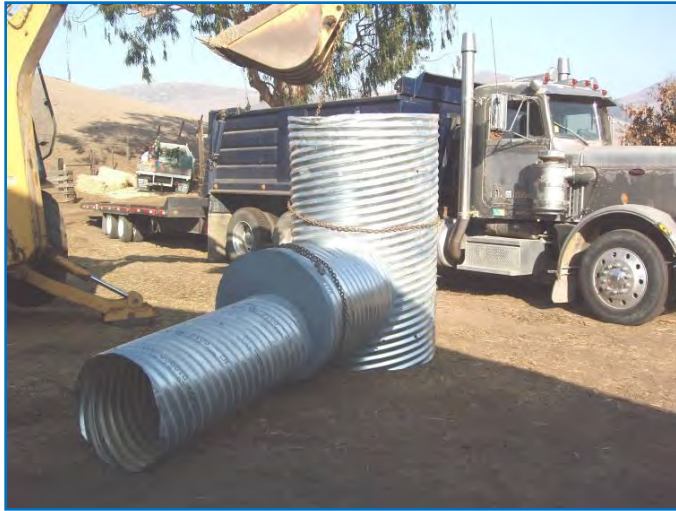
Figure 19. Drop structure prior to placement.

Construction: A large drop structure was installed to channel flow under the historic stone bridge without erosion.

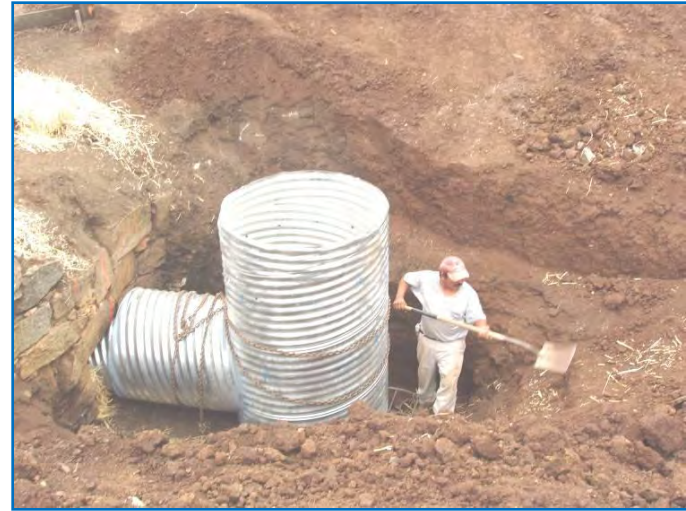
Figure 20. Placed drop structure.

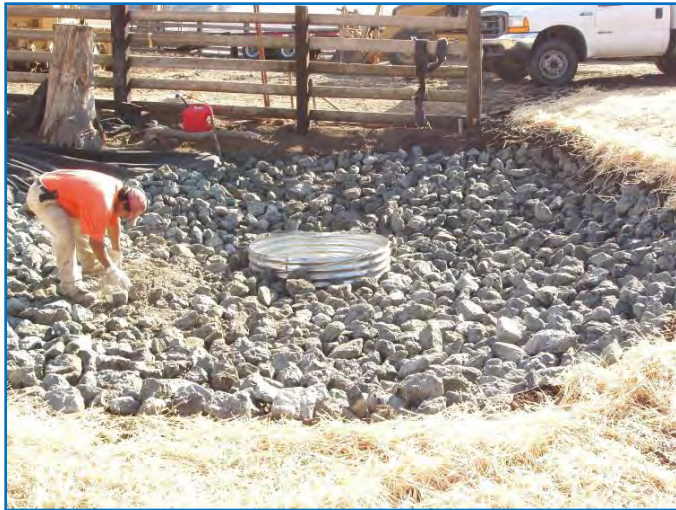
Figure 21. Looking downstream at riprap around drop.

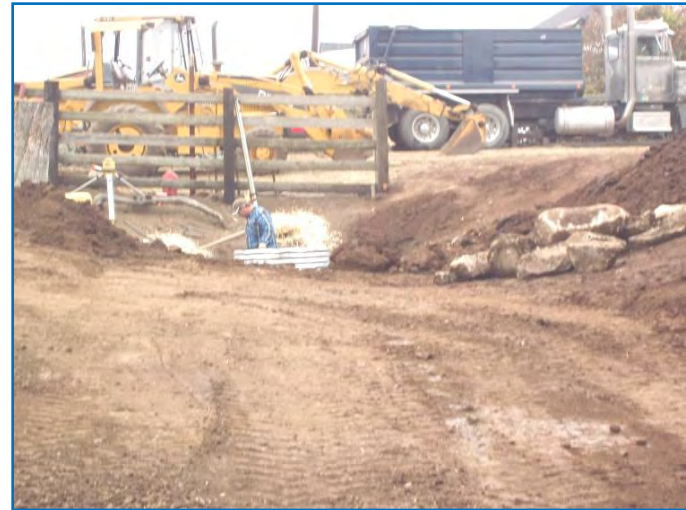
Figure 22. Headcut backfilled.

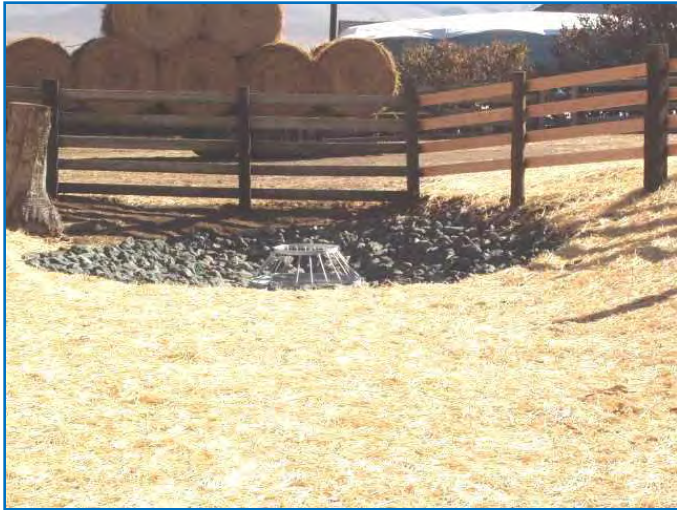
Figure 23. Installed drop structure and grate.

Completed project. looking downstream towards drop and grate, looking upstream at drop and grate during large storm, looking upstream at outlet of existing rock culvert during storm.

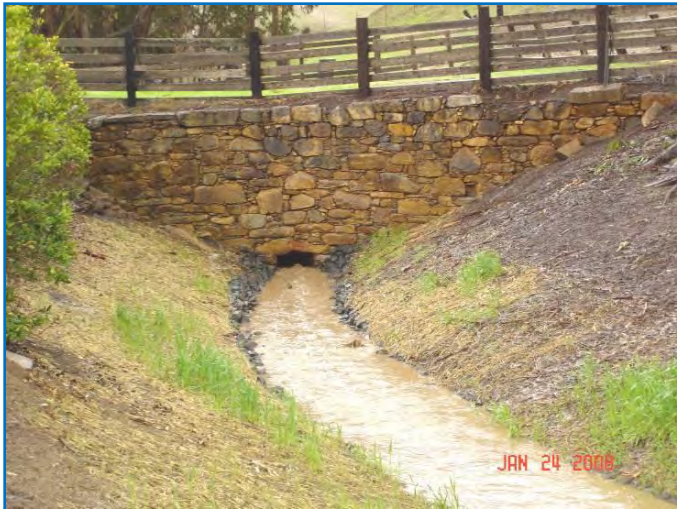
Figure 24. Looking upstream at outlet under stone bridge. Revegetated slopes are sprouting.

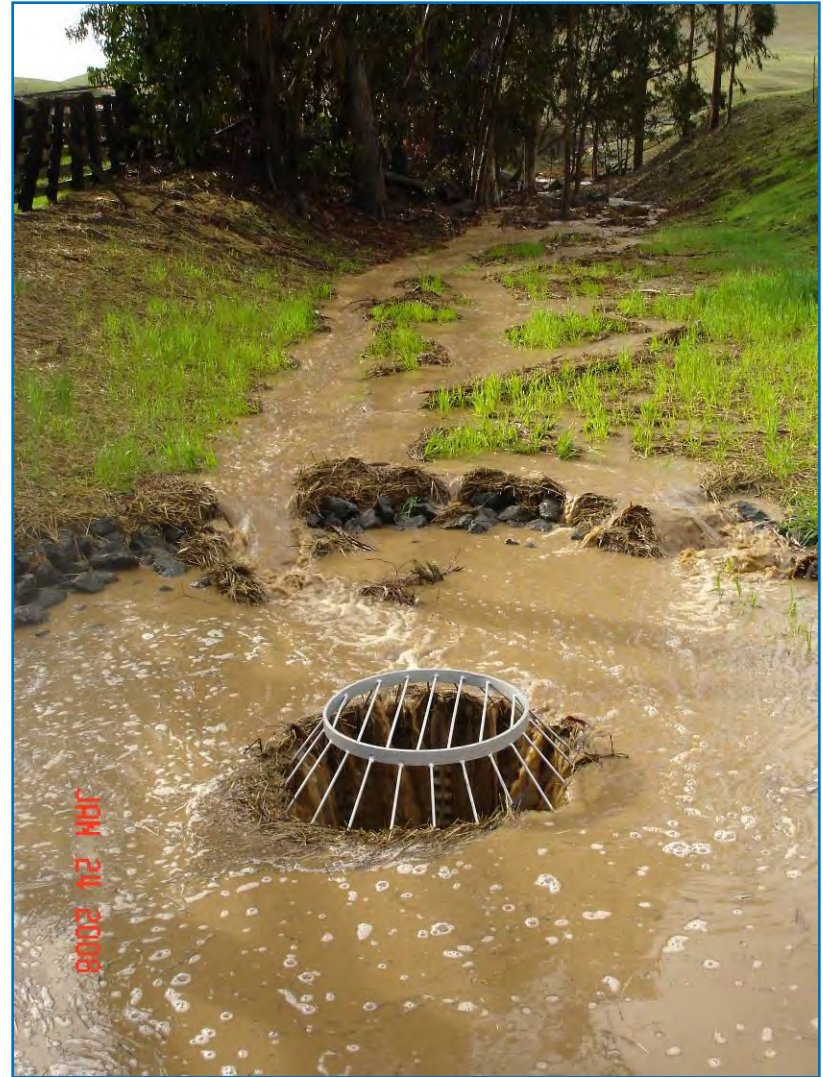
Figure 25. Looking upstream at drop structure and restored headcut during storm.

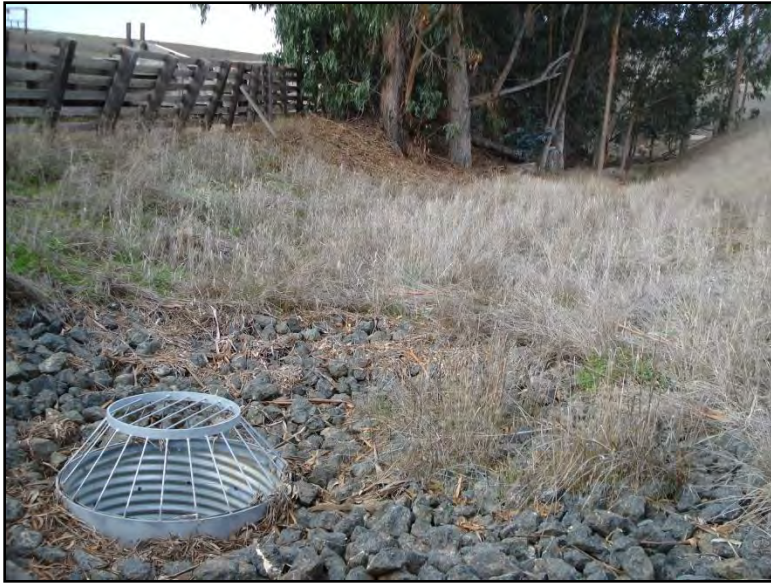
Figure 25a. Looking upstream at drop structure and restored headcut, over a year after installation

Post-implementation photos: A site visit conducted December 1, 2008 found the stabilized headcut and drop structure on the upstream side of the rock bridge in good condition and functioning well, and the recontoured and revegetated banks on the downstream site stable with no signs of scour or downcutting.

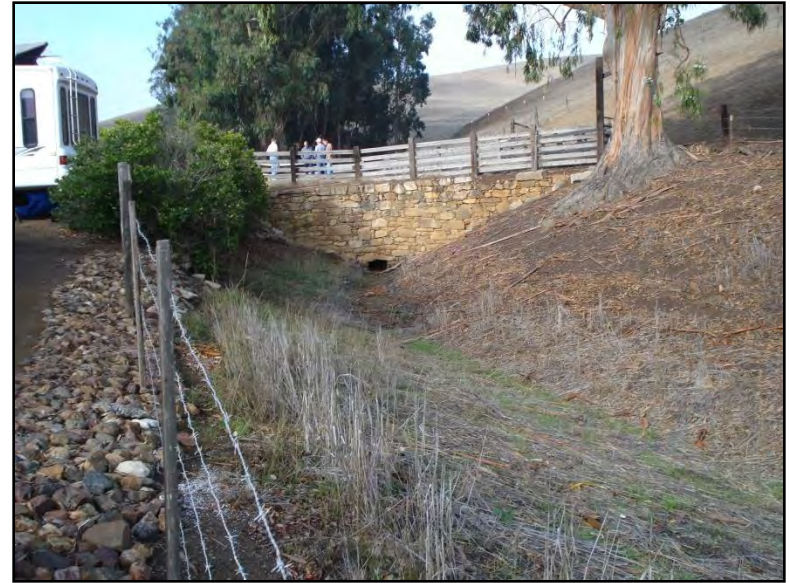
Figure 25b. Looking upstream at outlet and recontoured/revegetated banks.

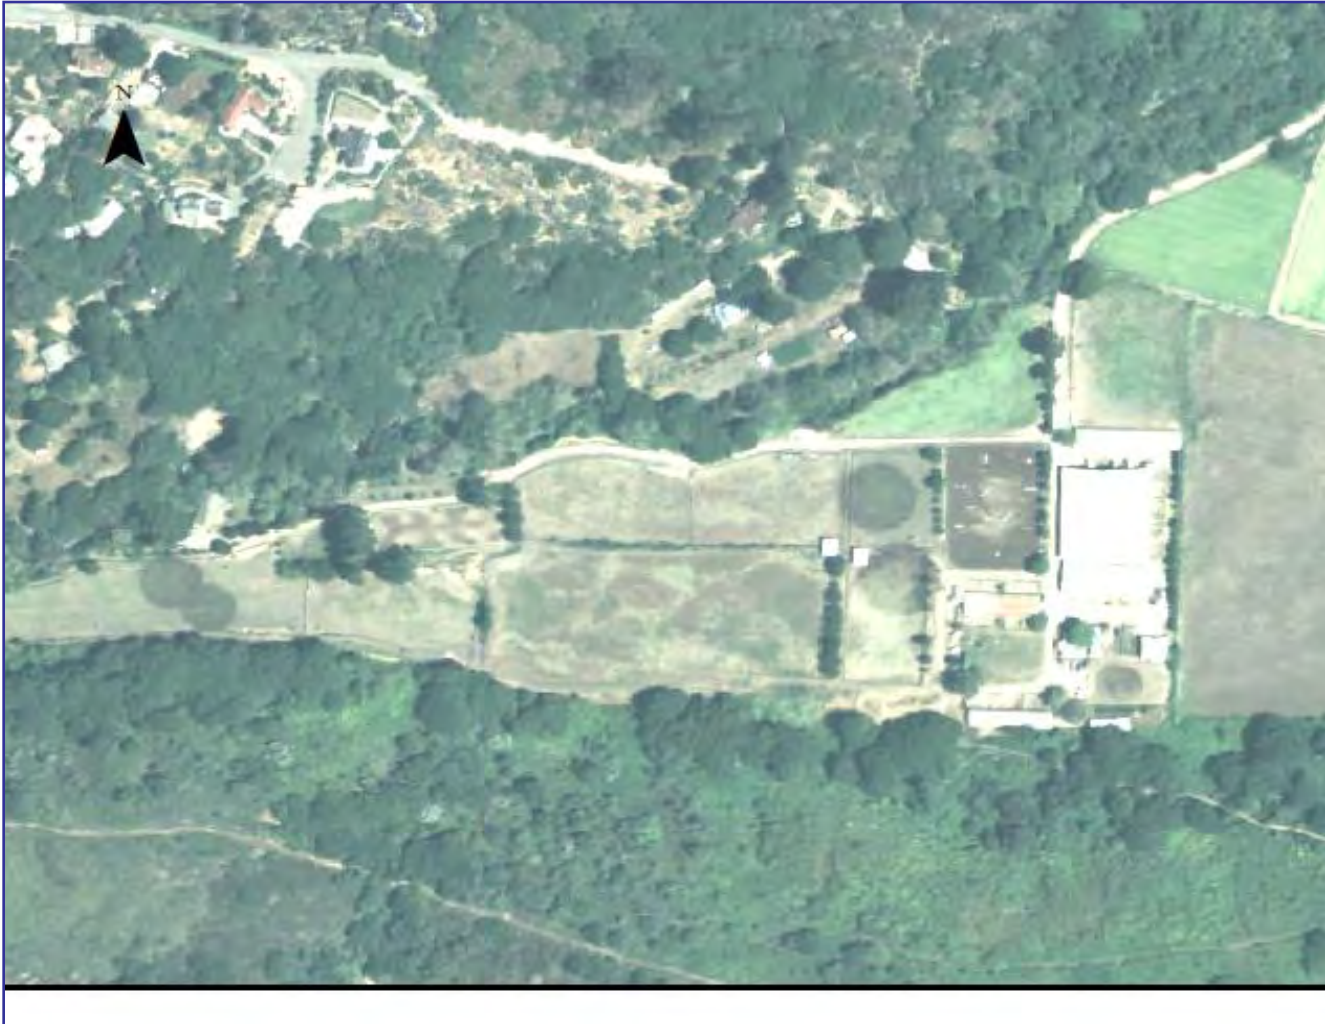
Figure 26. Aerial view of equestrian facility adjacent to tributary to Los Osos Creek.

Resource concern: To minimize waste management problems associated with a 50 horse capacity boarding facility that borders a blue line stream.

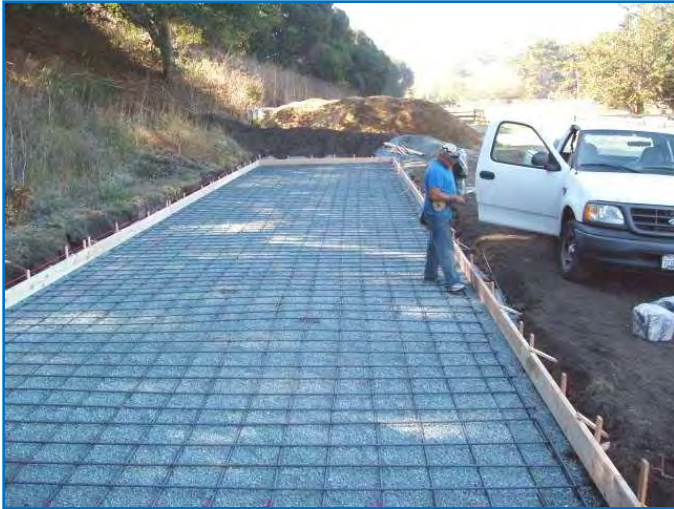
Figure 28. Contractor tying steel for pad.

Construction: A concrete pad was poured to provide an impermeable surface on which to compost manure.

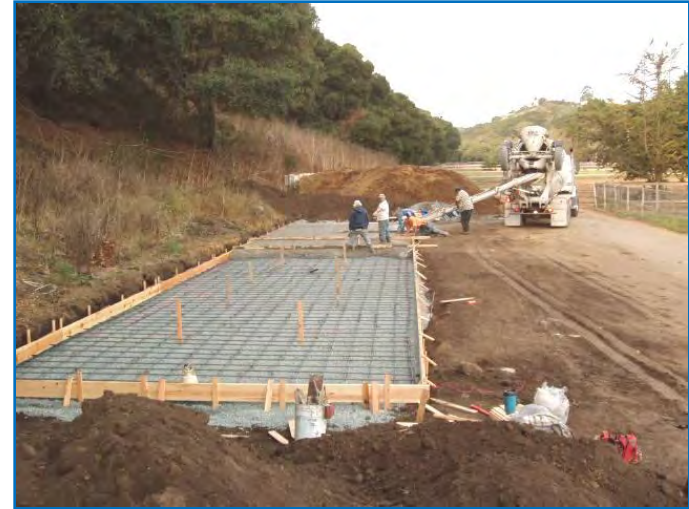
Figure 29. Pouring concrete.

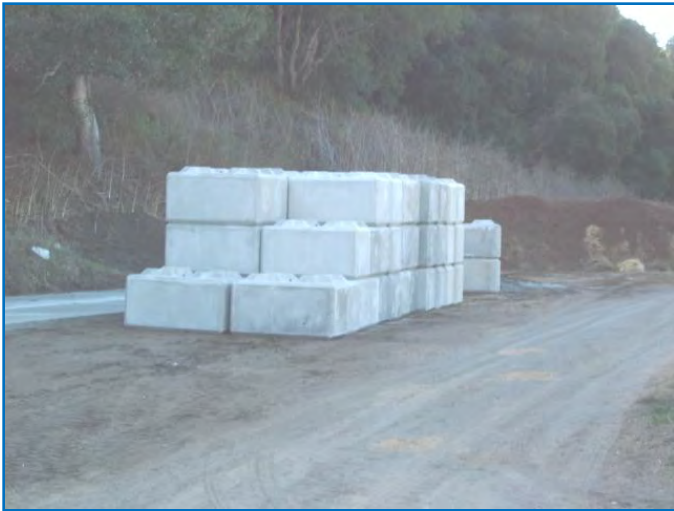
Figure 30. Inter-lock blocks off-loaded from truck, prior to placement on pad.

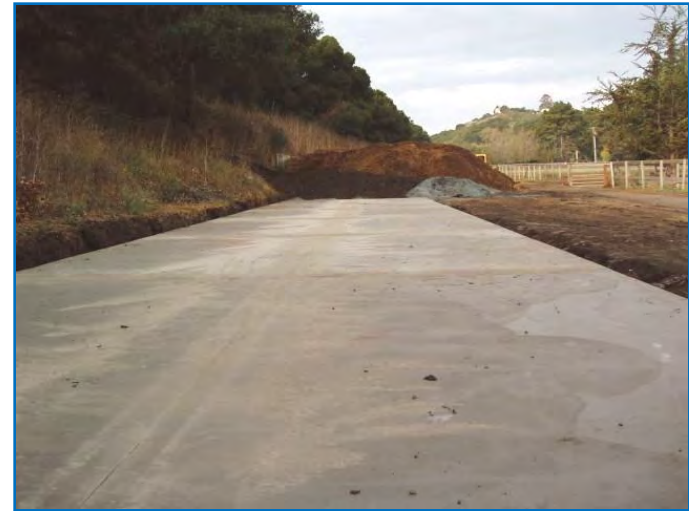
Figure 31. Finished pad.

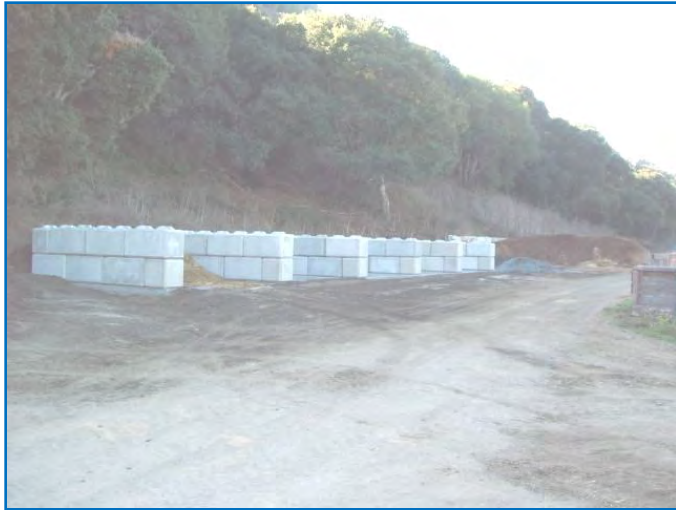
Figure 32. Blocks creating 5-bin compost facility.

Completed project. The landowners began storing manure in the bins for composting as soon as facility was completed.

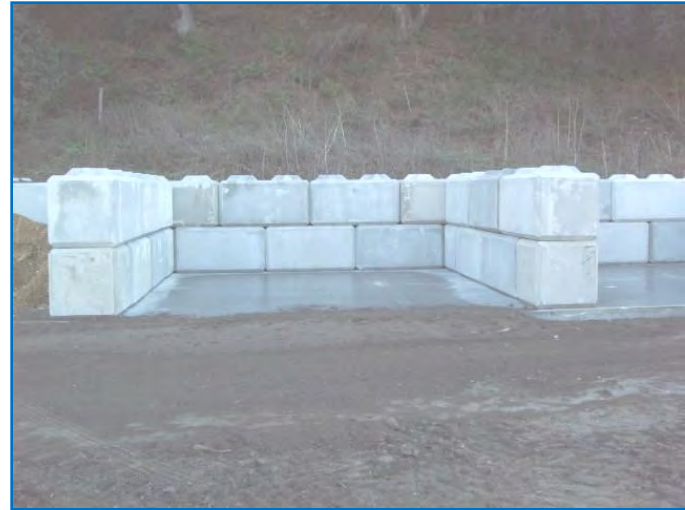
Figure 33. View of one 15' x 15' x 5' bin.

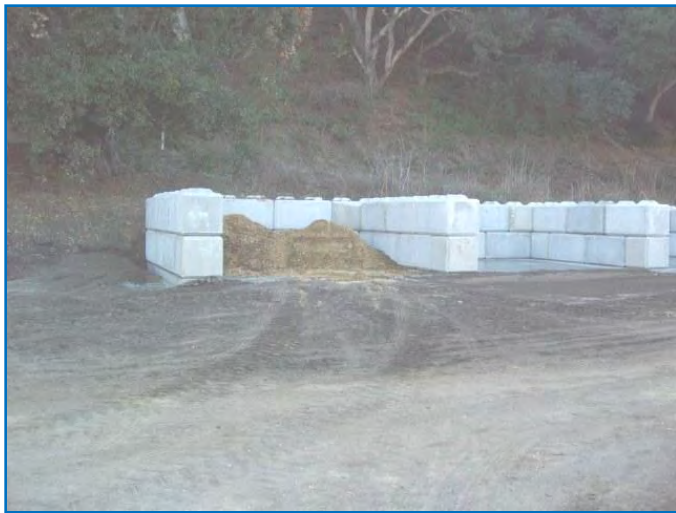
Figure 34. The first bin beginning to be filled with manure.

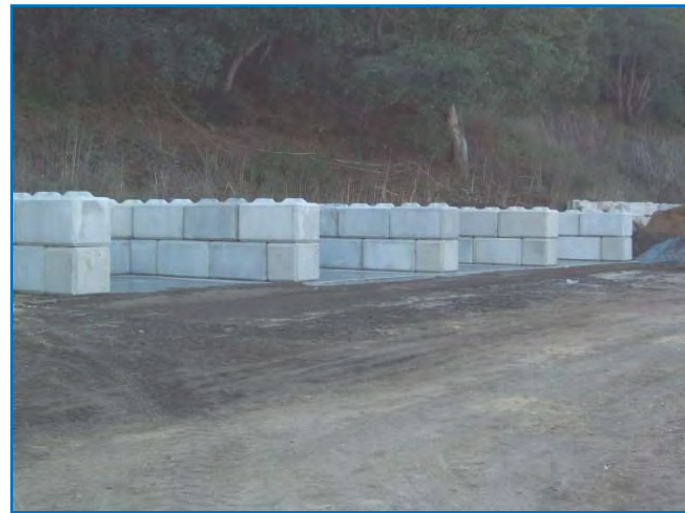
Figure 35. Closer view of 4 of 5 bins.

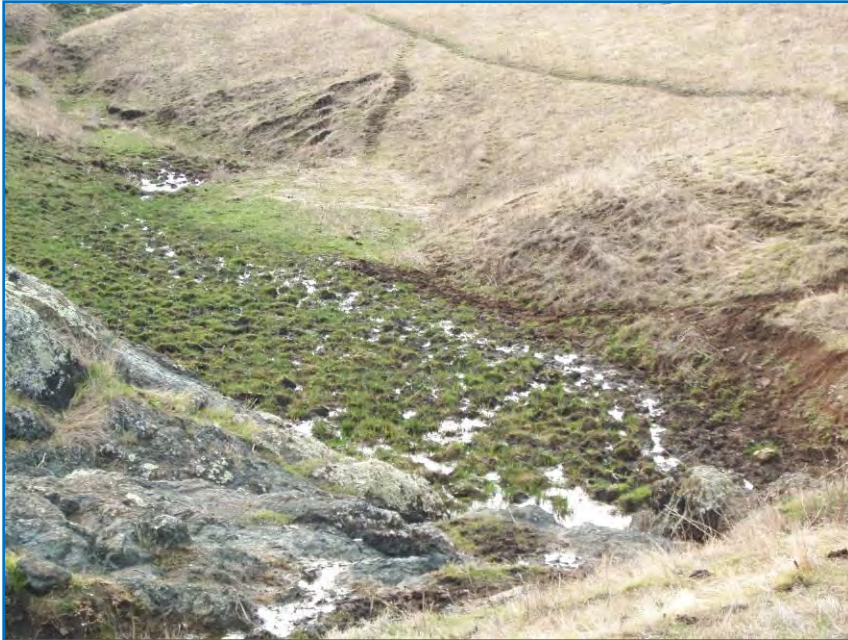
Figure 40. Site shown is just below development site of the upper spring in pasture 1. Note the hoof prints in the mud.

Resource concern: Impaired water quality and riparian vegetation due to cattle in creek (parameters of concern include pathogens) and limited cattle access to an off-creek water supply.

Solution: In association with the Morro Bay National Estuary Program’s plan to install riparian fencing, a Comprehensive Conservation Plan was developed that provides off creek watering for cattle.

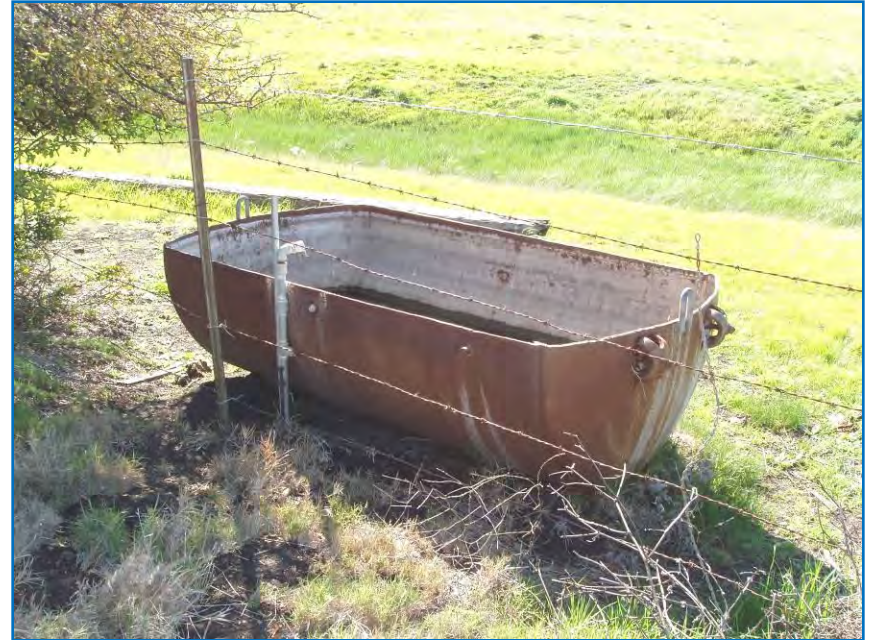
Figure 41. An existing non-functional water trough under scores the lack of an available off-creek water supply for cattle.

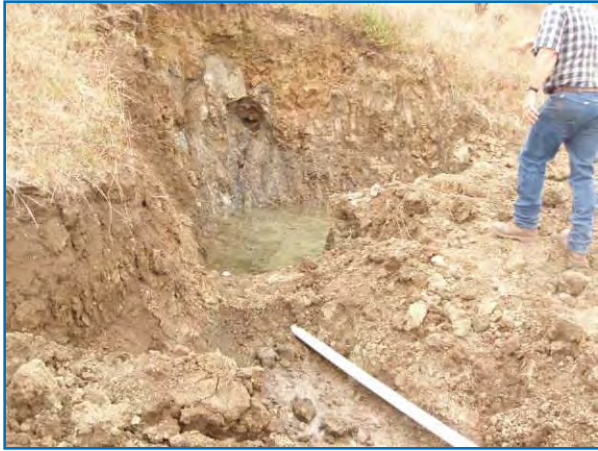
Figure 44. Development of upper spring in pasture 1.

Construction: The project included installing over 3500 feet of pipeline and 3 tanks to supply 10 watering troughs.

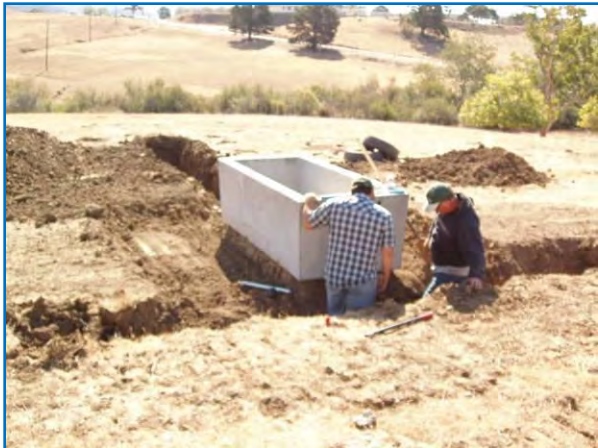
Figure 47. Installation of trough in pasture 5A.

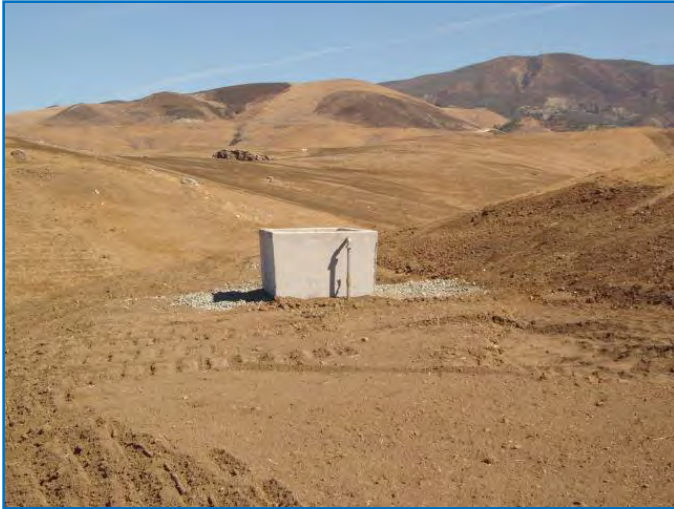
Figure 50. Trough supplied from lower fire hydrant in field 5A.

Completed project: Figures 50 through 53 show installed components of off-creek watering system at Camp San Luis.

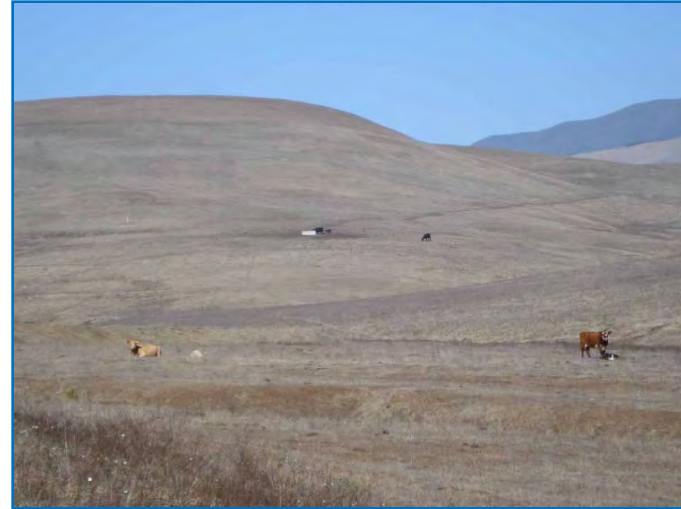
Figure 51. Trough from upper spring in pasture 1 shown in the distance.

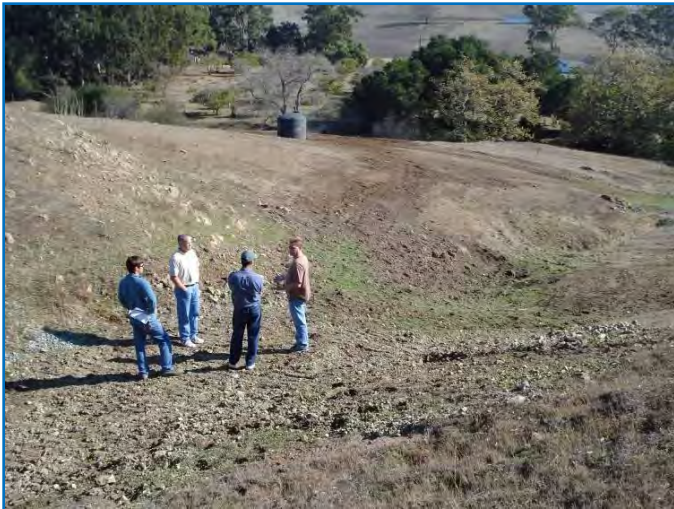
Figure 52. SWRCB project tour group shown at completed lower spring in pasture 1, with storage tank downhill.

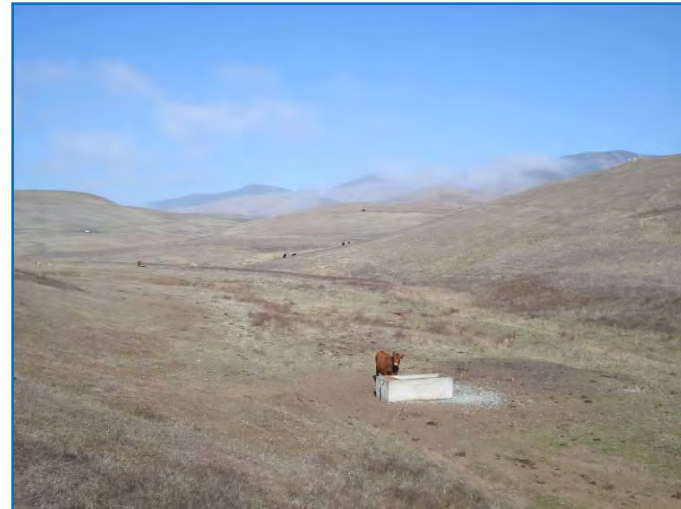
Figure 53. Trough from lower spring in pasture 1.

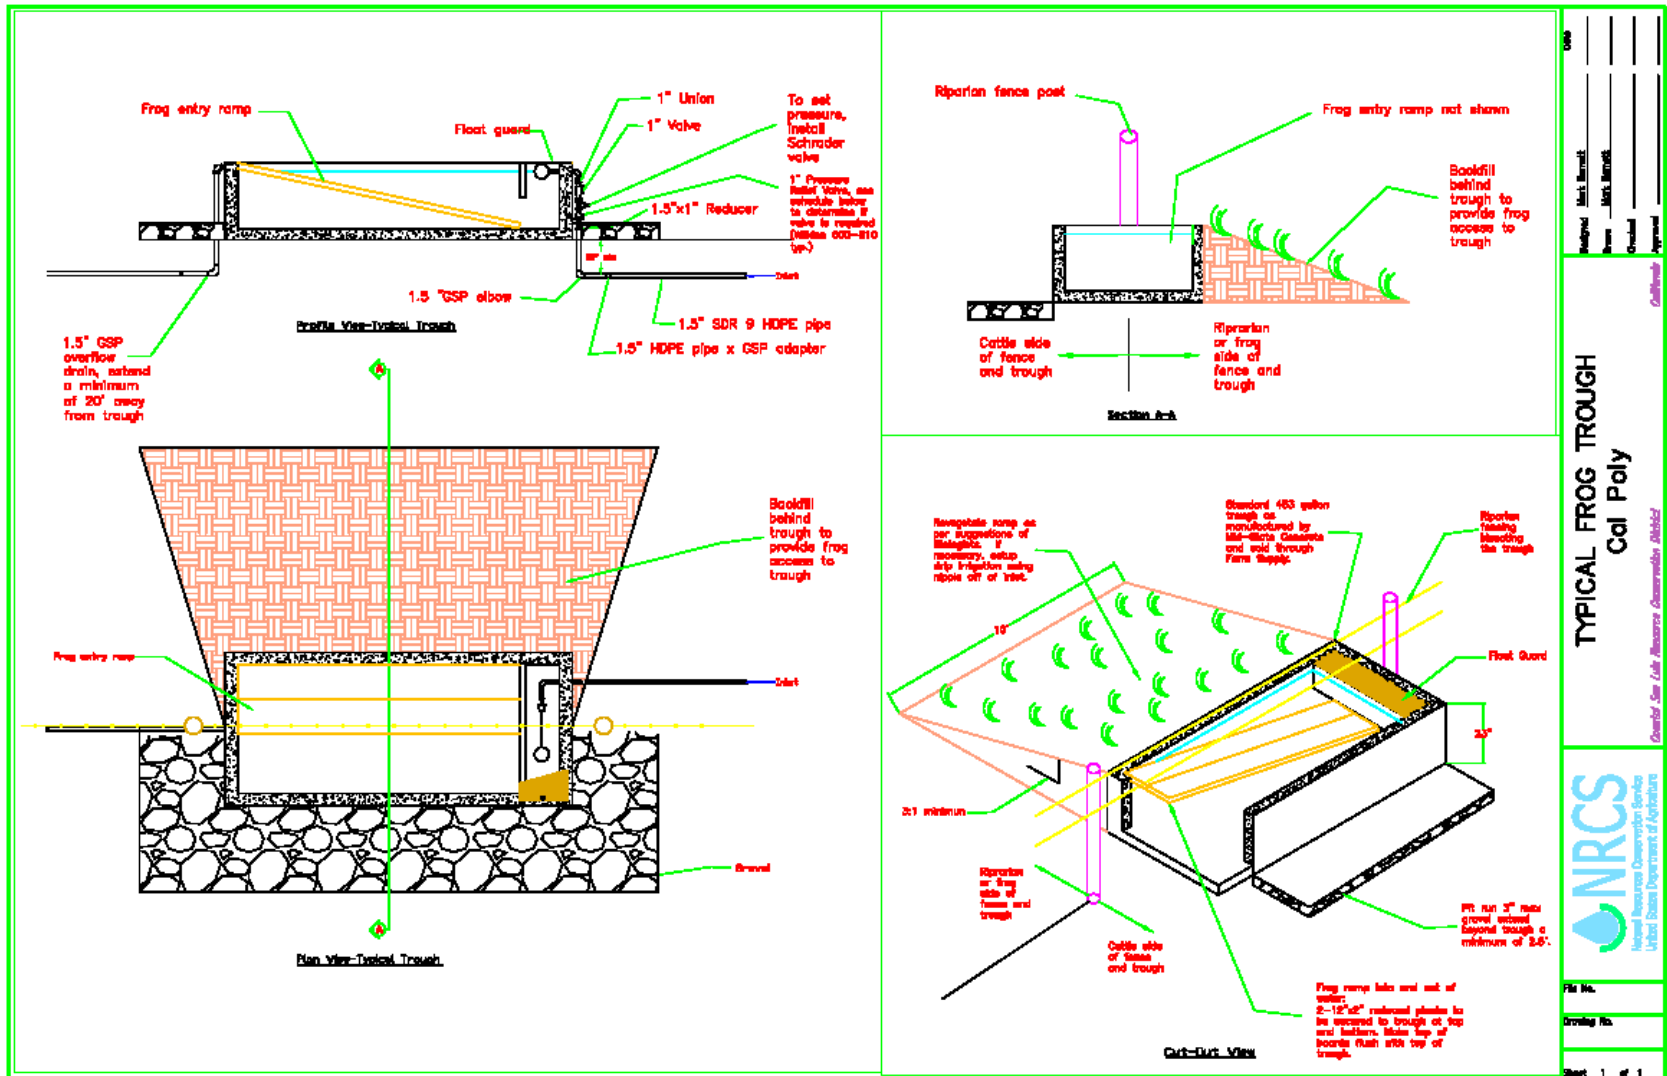
TYPICAL FROG TROUGH
 Cal Poly
 Council: See Lake Resource Coordinator's Website
 NRCNS
 Natural Resource Conservation Service
 United States Department of Agriculture

Figure 57. Design for water troughs that facilitate access by red-legged frogs.

Solution: Design a water trough that allow frogs easy access into and out of the trough as well as providing protection from bullfrogs.

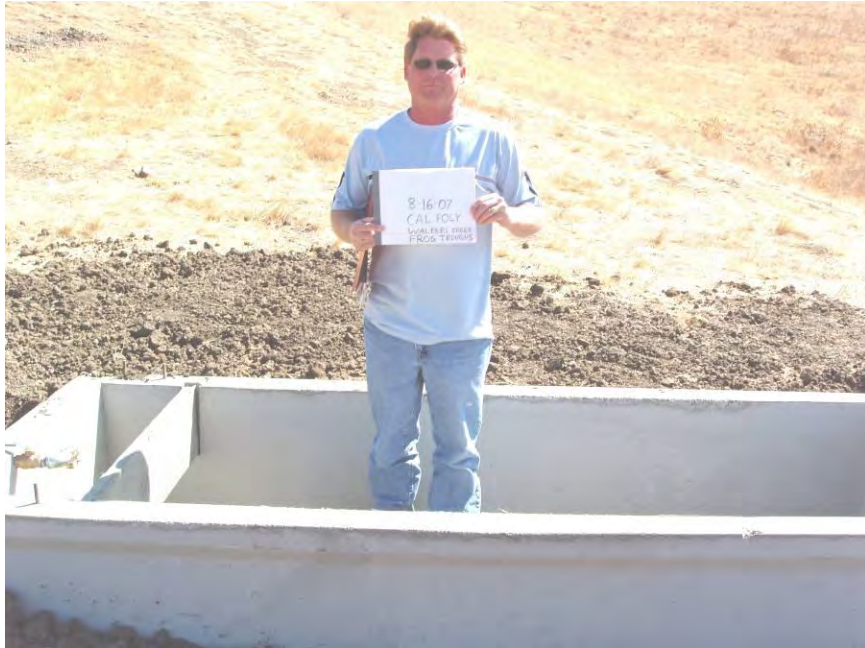
Figure 58. Trough in place in Walters Creek.

Construction: Two of the pre-formed water troughs after being set in place.

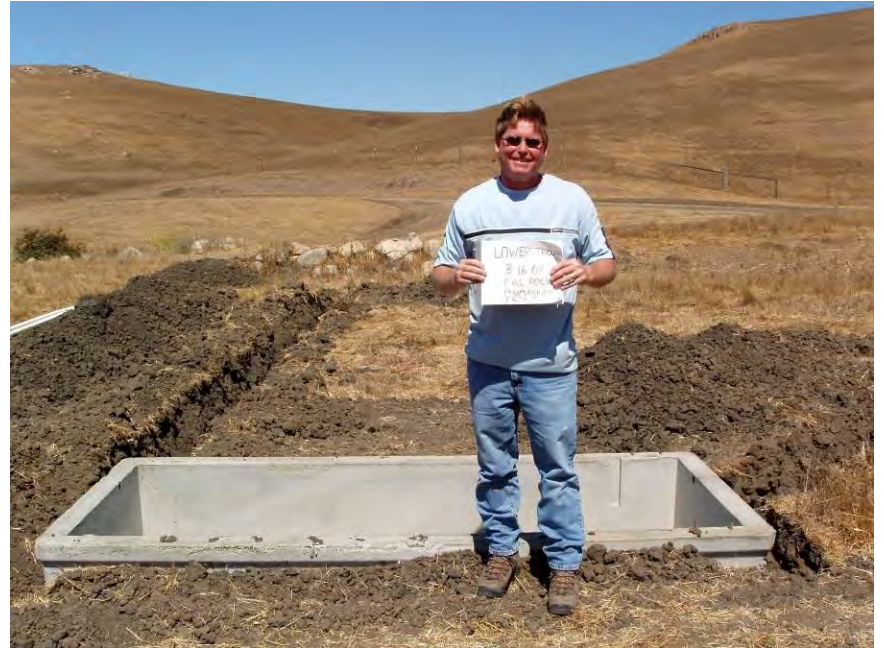
Figure 59. Trough set in place at Chumash Creek.
