Summary of 319h Projects and Practices Implemented through Grant No. 06-128-553-0 "Project Clearwater"

ATTACHMENT E
[San Bernardo Creek Managed Grazing Project PC-04-10](#)

ATTACHMENT E
Grade Stabilization Turri Road Ranch House PC-05-15

[Los Osos Valley Horse Manure Composting Project PC-06-08](#)

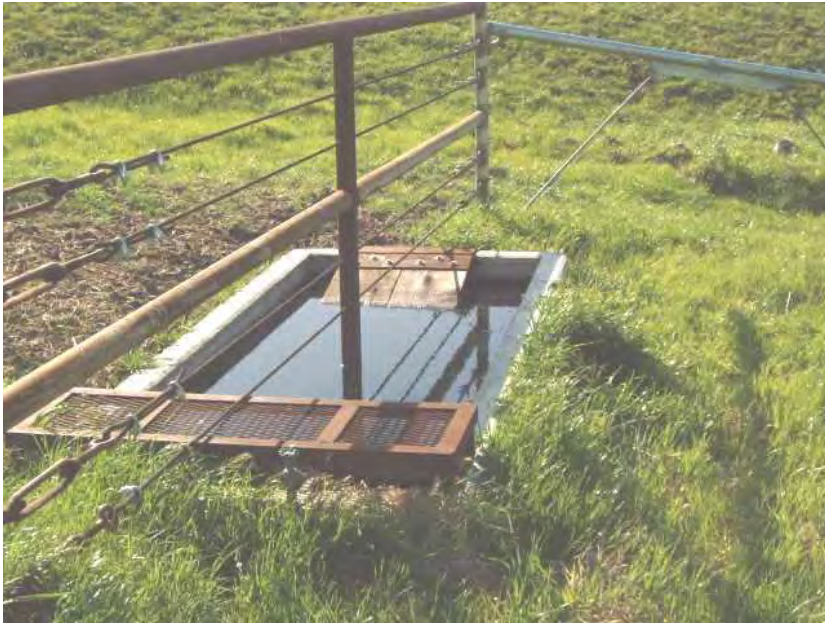
Figure 60. Completed red-legged frog-friendly water trough in Walters Creek watershed, bisected by fence so as to be accessible by cattle from either pasture.

Completed project: The two completed "frog troughs" on Cal Poly land allow off-creek water access to cattle from two pastures.

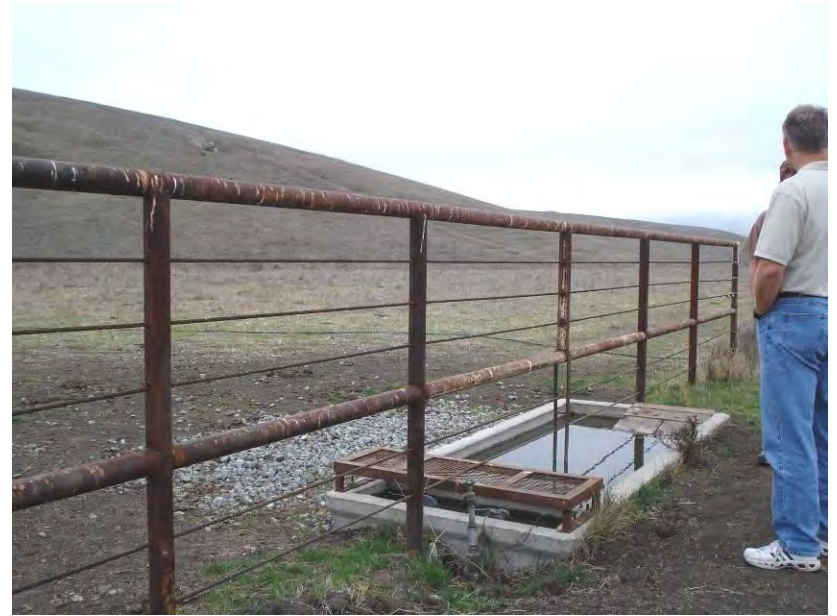
Figure 61. Completed "frog trough" in the Chumash Creek watershed.

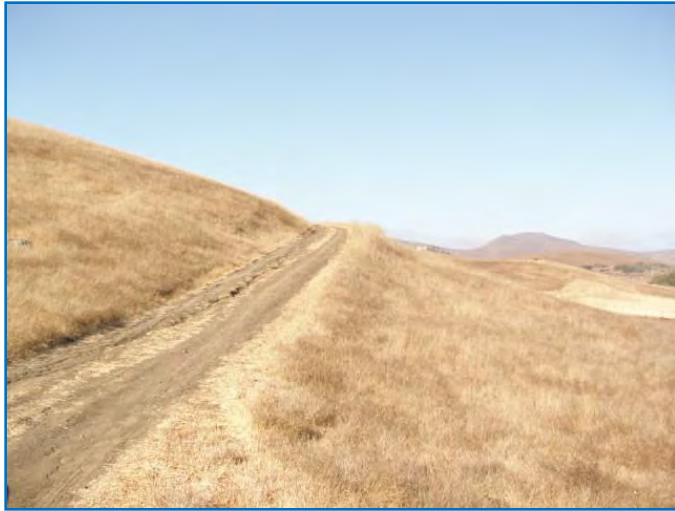
Figure 62. Erosion in middle of road.

Resource concern: Views of inadequately designed dirt roads on Cal Poly's Walter's Creek Ranch, showing evidence of soil erosion in the form of rilling and incipient gullies.

Solution: Outslope access roads and install rolling dips where appropriate.

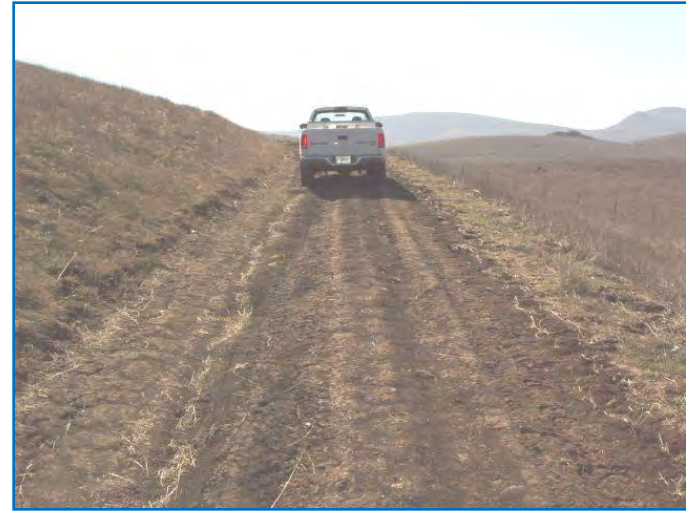
Figure 63. Developing gully in road.

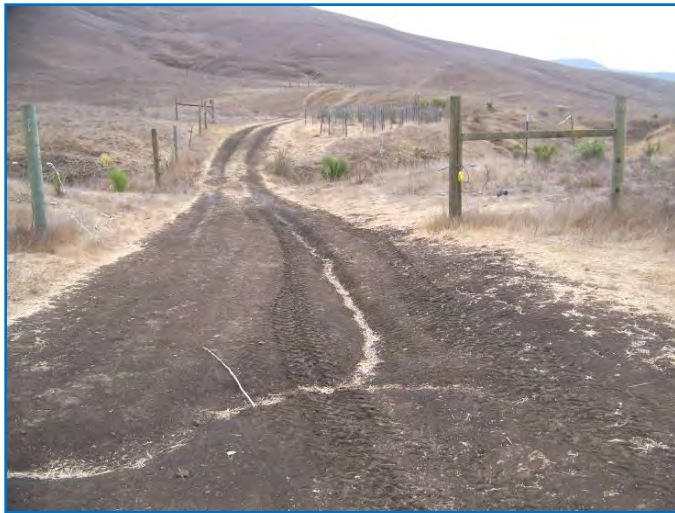
Figure 64. Another site of soil erosion.

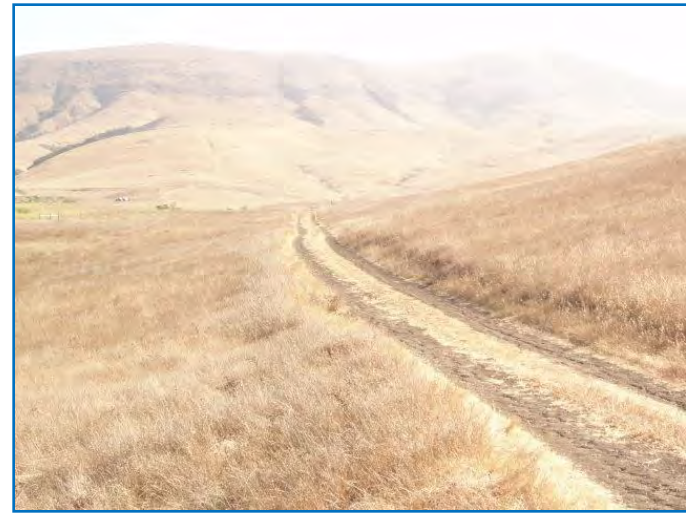
Figure 65. Rilling evident on unvegetated portions of road.

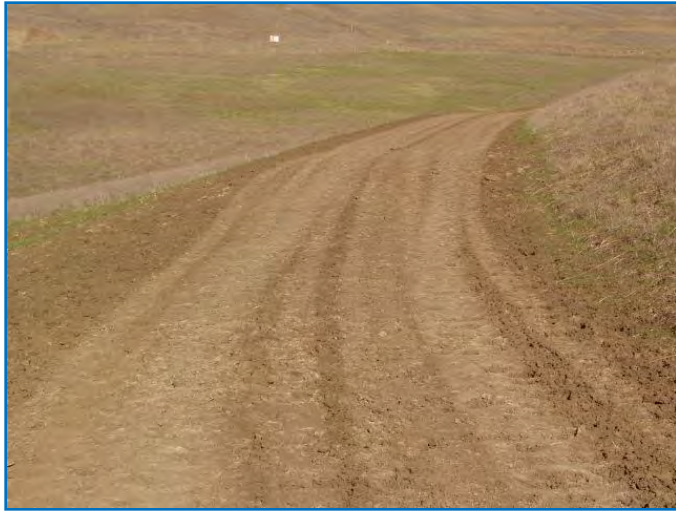
Figure 67. Outsloped road 1.

Completed project pictures of out-sloped access roads and rolling dips.

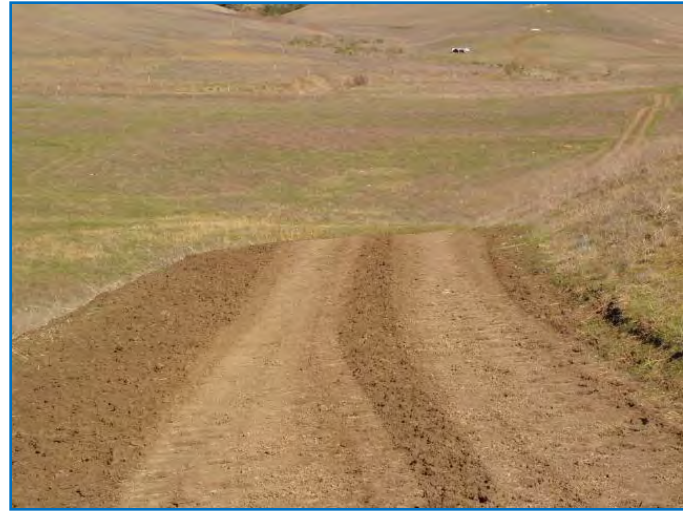
Figure 68. Outsloped road 2.

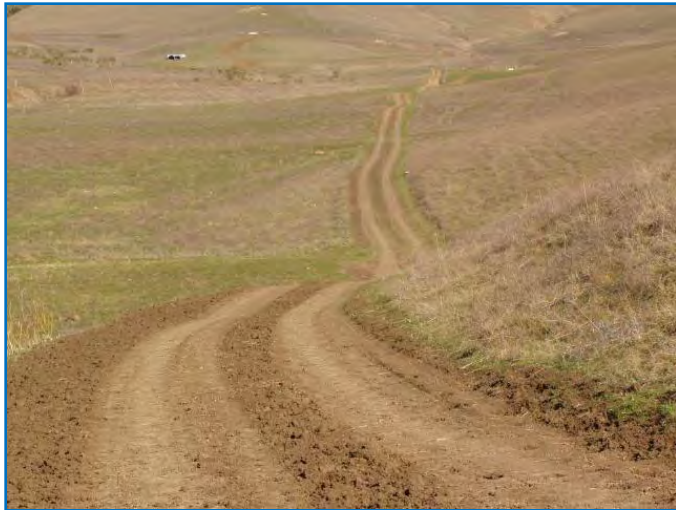
Figure 69. Outsloped road 3.

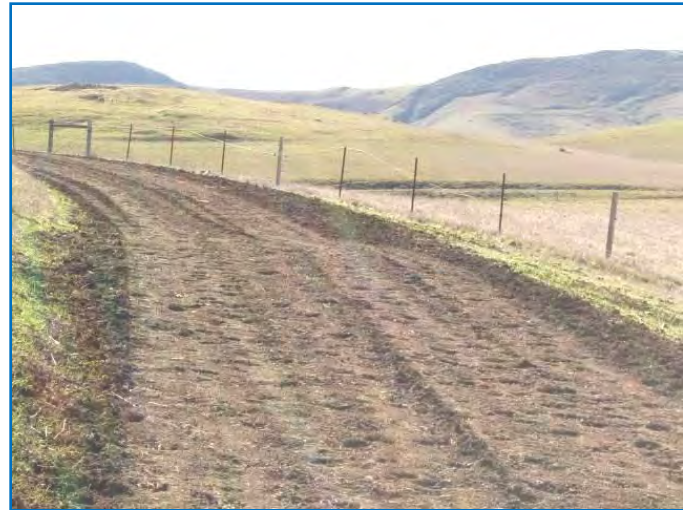
Figure 70. Outsloped road 4.

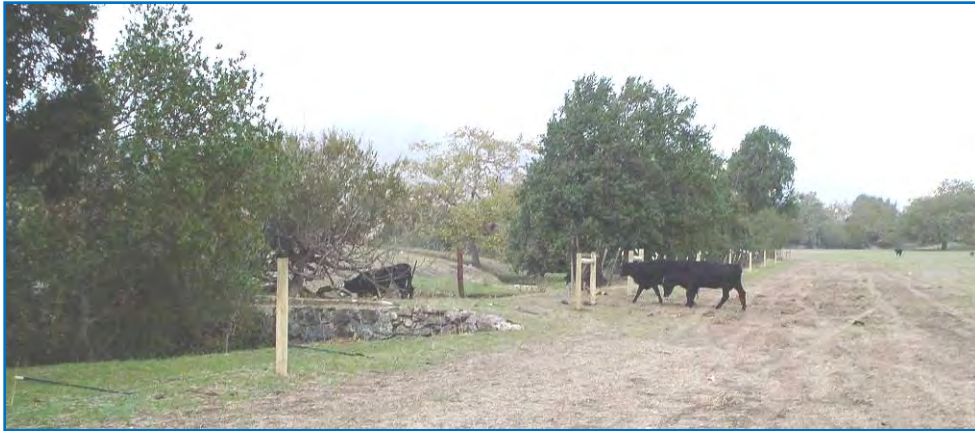
Figure 71. Cattle heading toward creek.

Resource concern: Impaired water quality and riparian vegetation due to cattle in creek; water quality parameters of concern include pathogens.

Solution: Prevent cattle access to creek with riparian fencing and off creek watering system.

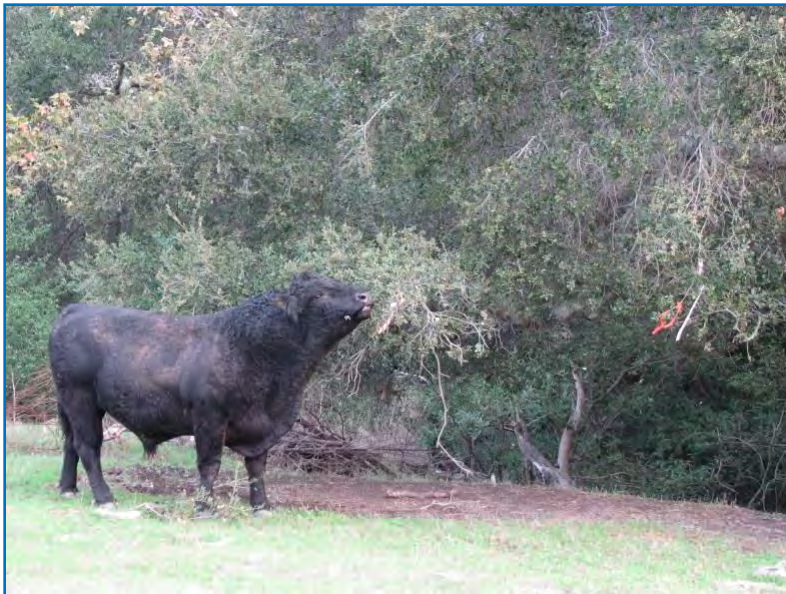
Figure 73. Bull browsing tree in riparian area.

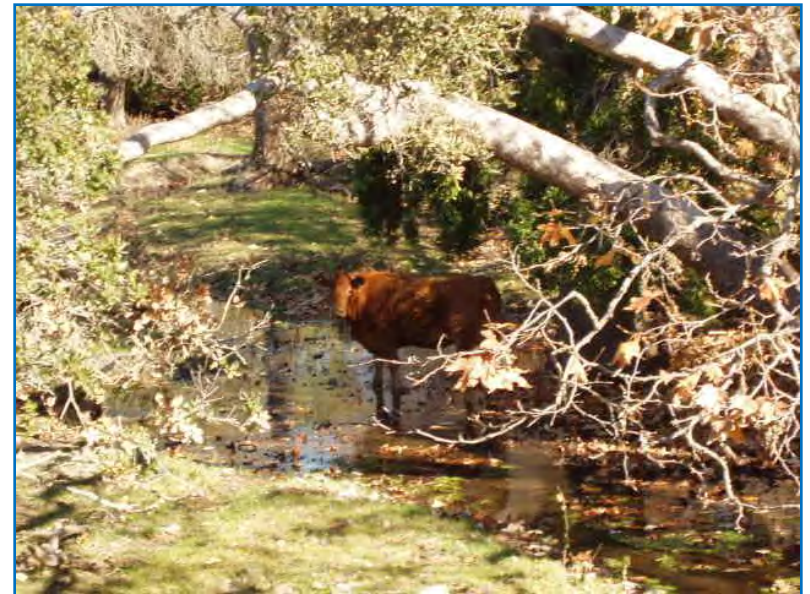
Figure 74. In the creek.

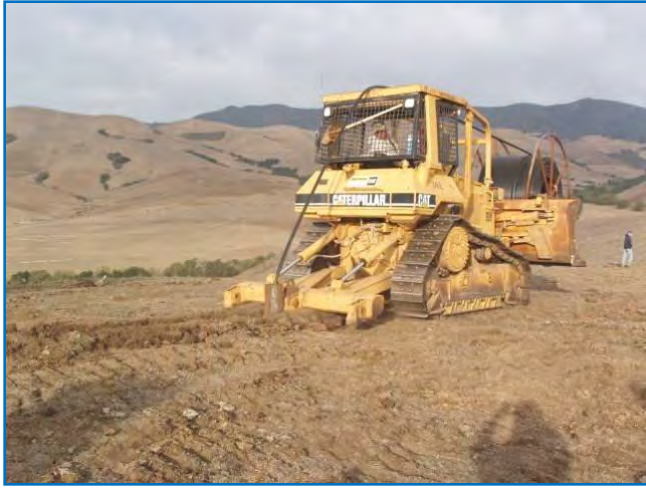
Figure 76. Cat and spool system used to rip in pipe.

Construction. Various stages of construction, including pipe, well and tank installation.

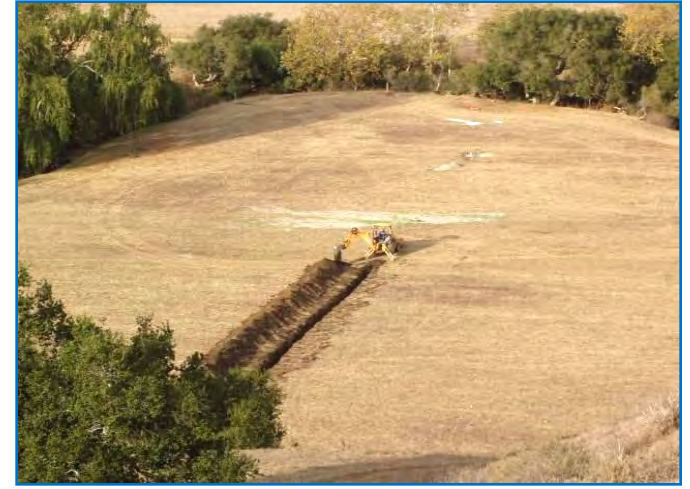
Figure 78. Backhoe used to install pipe in hayfield in order to get 48" depth.

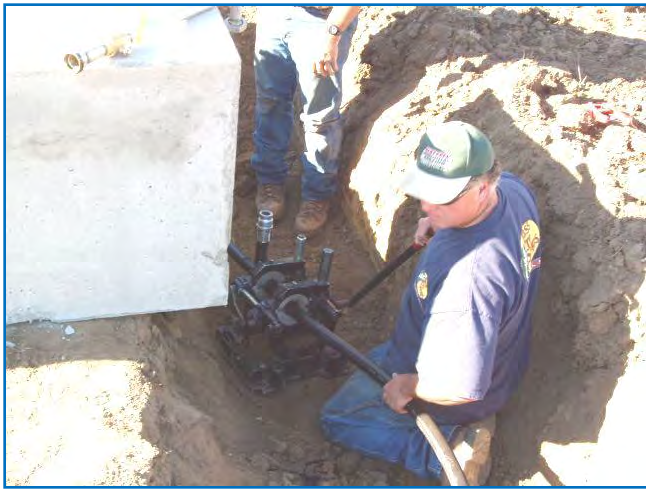
Figure 79. Installing tee to trough #30 with fusion welder.

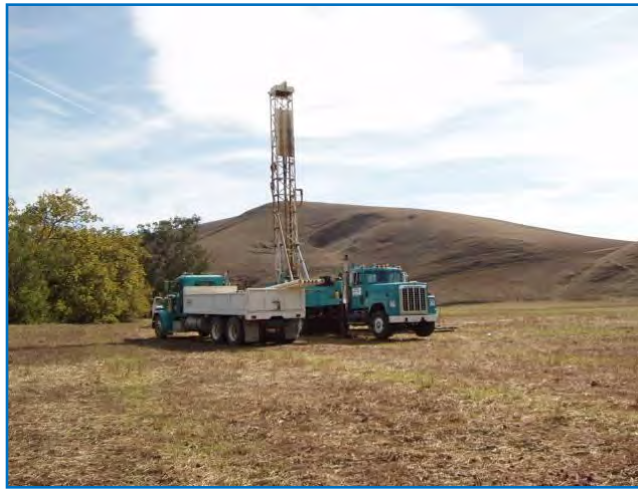
Figure 80. Site 1 well installation.
