RE: Asbestos Building Inspection – 1951 Turri Road, Los Osos, California

INTRODUCTION

This report presents the findings of West Coast Safety Consultants inspection for asbestos containing building materials at a single family residence and associated barn and shed located at 1951 Turri Road, Los Osos, California on October 3, 2015. All accessible areas were visibly inspected and samples of suspect material were obtained and analyzed.

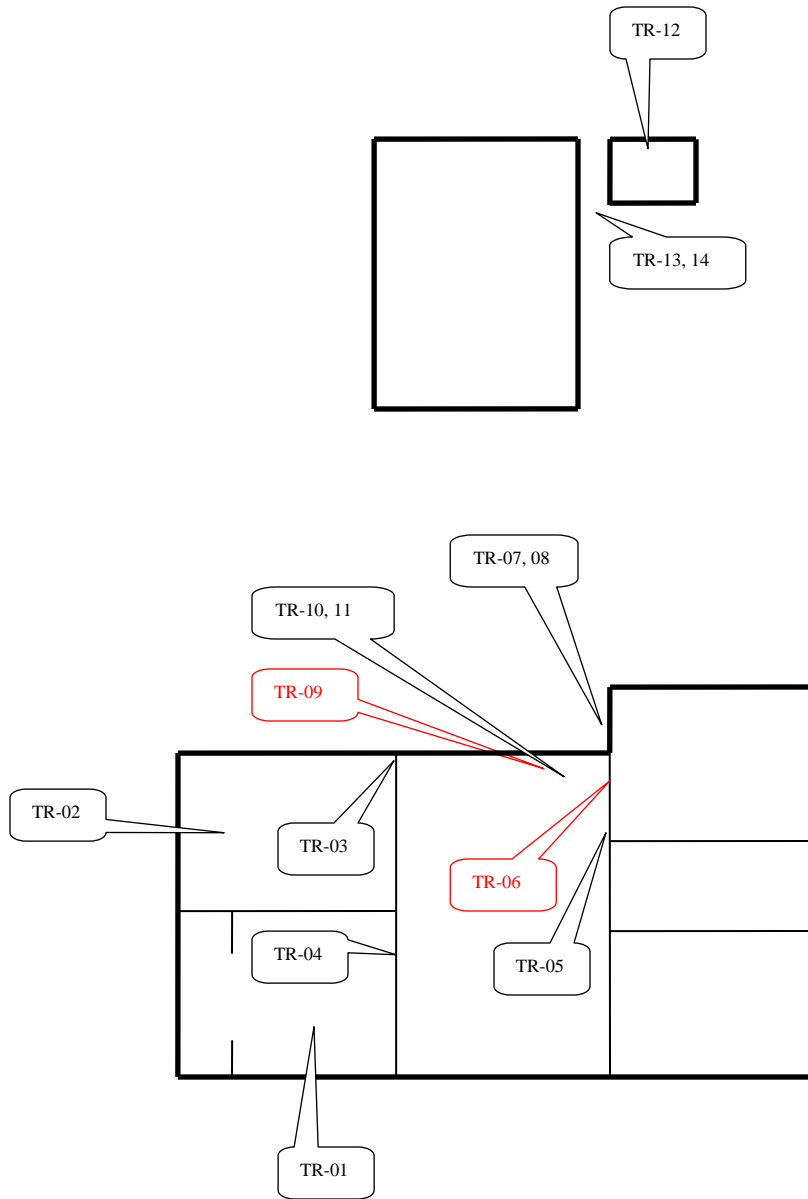
SAMPLE LOCATION DIAGRAM

1951 Turri Road
Los Osos, California

3. Analyzed the sample results and generated this report which includes:
 - a. Definitions
 - b. Executive Summary
 - c. Findings
 - d. Conclusions and Recommendations
 - e. Sample Result Summary (Appendix A)
 - f. Sample Location Diagram (Appendix B)
 - g. Laboratory Report (Appendix C)
 - h. Inspectors Credentials (Appendix D)
